**Fire Risk Assessment**

**1-16 Belvedere Court**

Version 3

2 February 2021

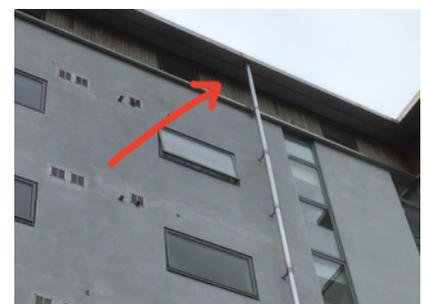
Timber cladding on the sixth floor.

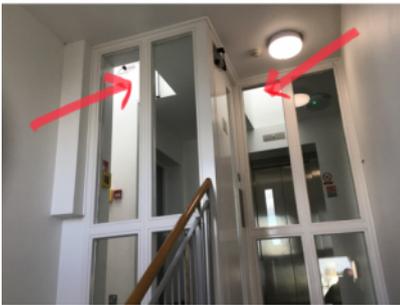
The positioning of the 6th floor lobby partition, means that the roof-light AOVs are only able to ventilate the top floor lobby, and will have no effect on the staircase where it is required. Ventilation is required for a building of this size and therefore this does not meet the minimum requirements of the building regulations at the time of construction which must have been signed off by the relevant building control body. Recommendations regarding possible solutions to remedy this matter are provided within this report.

6th floor partition viewed from staircase showing position of AOVs

This would have some minimal impact on the protection of the staircase at the top floor, however, this would only be affected if there is a fire in any off the 6th floor flats. Should a fire occur on the 6th floor, the AOV would actuate and is located in the immediate area of these flats and would therefore ventilate the and products of combustion away from the 6th floor.

Alternatively, reconfigure the openable windows in the staircase to have window AOVs fitted.

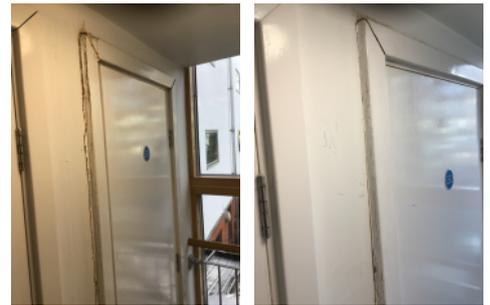
There are water services riser doors (including frames) on the first and second floors which have been damaged, presumably by a severe water leak at some time. These should be repaired to an FD30S standard of fire resistance.

Source Version	1
Category	Escape Routes & Fire Spread
Sub Category	Fire Doors
Action Required	Repair the following doors and frames to ensure that afford at least FD30S standard of fire resistance :  There are water services riser doors (including frames) on the first and second floors which have been damaged, presumably by a severe water leak at some time.
Priority	Medium
Status	Identified
Owner	Customer Homes
Due Date	4 September 2020

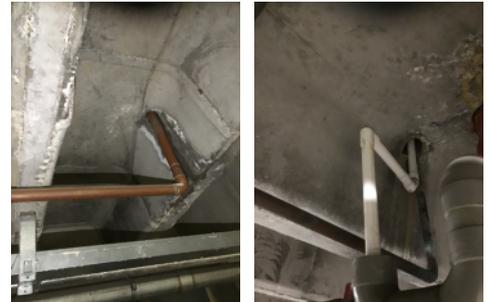
Cable and pipe penetrations in the underground carpark are for the most part, fire stopped to an acceptable standard. However, there are some smaller pipe penetrations which were noted not to have any fire stopping installed.

Source Version	1
Category	Escape Routes & Fire Spread
Sub Category	Construction and Glazing
Action Required	Provide fire stopping around pipe penetrations in the following locations:  Cable and pipe penetrations in the underground carpark are for the most part, fire stopped to an acceptable standard. However, there are some smaller pipe penetrations which were noted not to have any fire stopping installed.
Priority	Medium
Status	Identified
Due Date	4 September 2020
