**Fire Risk Assessment**

**1-27 Lyme Grove House**

Version 5

5 February 2021

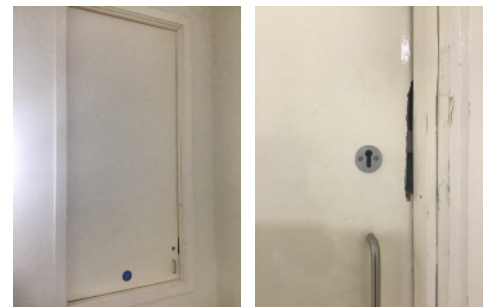
Source Version	1
Category	Escape Routes & Fire Spread
Sub Category	Fire Doors
Action Required	Repair the following doors to an FD30S standard:  Cupboard door in staircase, 7th floor.  Version 2 - This task has been completed.
Priority	Medium
Status	Completed
Due Date	30 January 2019

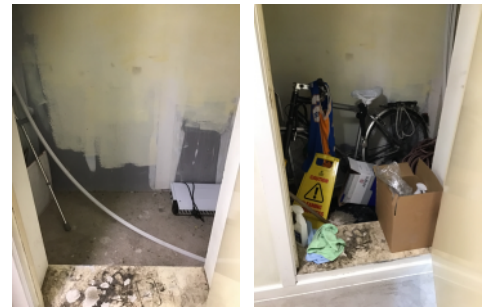
Source Version	1
Category	Fire Prevention
Sub Category	Housekeeping
Action Required	The storage of combustible items in smoke shafts should be prohibited.  VERSION 3: This task has not been remedied and combustibles are still found in this location.  VERSION 4: This task has been completed - 2nd photograph provided as evidence.
Priority	High
Status	Completed
Owner	Neighbourhood Services
Due Date	5 December 2018

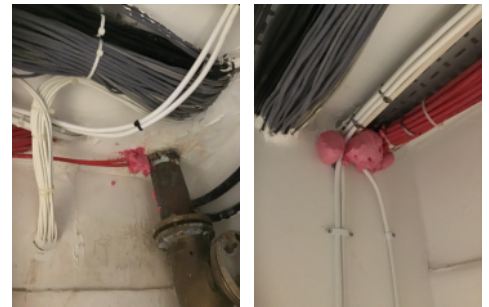
Source Version	4
Category	Escape Routes & Fire Spread
Sub Category	Construction and Glazing
Action Required	Pink intumescent expanding foam should not be used as fire stopping for large penetrations. Suitable fire stopping material should be used.  Electrical riser, 1st floor.
Priority	Medium
Status	Identified
Owner	Customer Homes
Due Date	20 January 2021
