Fire Risk Assessment

17-42 Belvedere Court

Version 3

2 February 2021

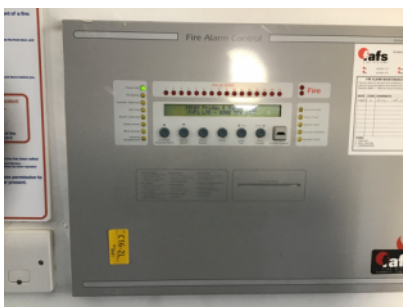
Fire alarm control panel

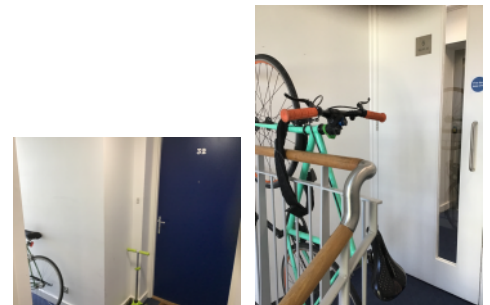
Task 5

Source Version	1
Category	Escape Routes & Fire Spread
Sub Category	Ease of Use
Action Required	Bikes should not be stored as to obstruct escape routes. A bicycle was located on the 6th floor landing. A bicycle and scooter was located in the 4th floor lobby.
Priority	Medium
Status	Identified
Due Date	4 September 2020

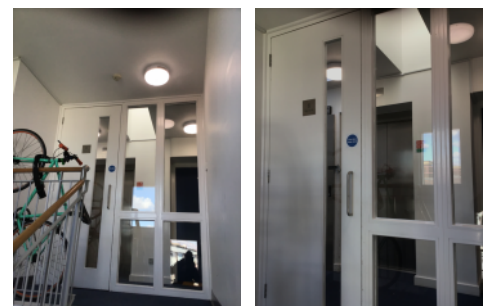
Task 6

The positioning of the 6th floor lobby partition, means that the roof-light AOVs are only able to ventilate the top floor lobby, and will have no effect on the staircase where it is required. Ventilation is required for a building of this size and therefore this does not meet the minimum requirements of the building regulations at the time of construction which must have been signed off by the relevant building control body. Recommendations regarding possible solutions to remedy this matter are provided within this report.

Source Version	1
Category	Escape Routes & Fire Spread
Sub Category	Smoke Ventilation
Action Required	Remove the staircase door to the 6th floor lobby, to enable the roof-light AOV to be able to ventilate smoke from the staircase in the event of a fire.
Priority	High
Status	Identified
Due Date	4 June 2020

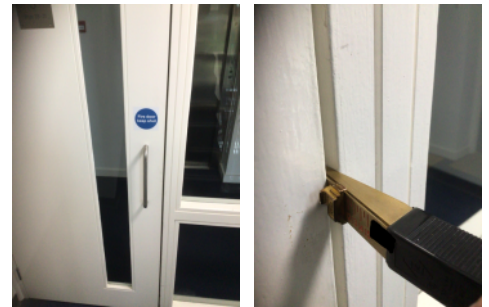
Task 11

Source Version	3
Category	Escape Routes & Fire Spread
Sub Category	Fire Doors
Action Required	Re-hang the following doors to reduce the gaps around the doors: Staircase doors have excessive gaps in excess of 11mm
Priority	Medium
Status	Identified
Owner	Customer Homes
Due Date	3 August 2021
