**Fire Risk Assessment**

**20 and 20A Ainsworth Road**

Version 4

22 September 2021

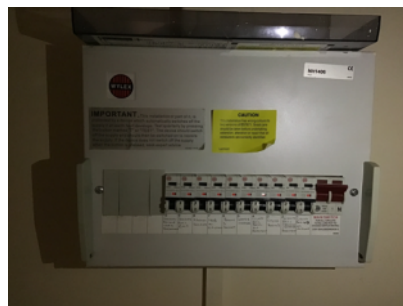
Consumer unit, 2nd floor in No.20, evidence of testing

Consumer unit in No.20A, no test label

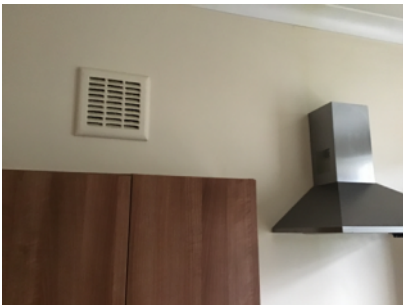
Wall vent in kitchen, to open air

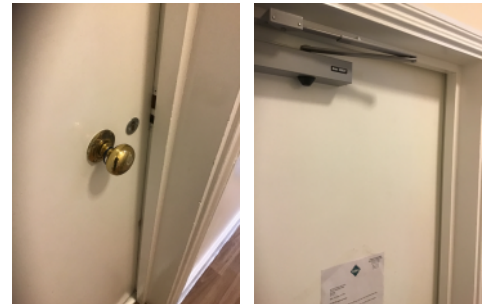
Source Version	3
Category	Escape Routes & Fire Spread
Sub Category	Fire Doors
Action Required	VERSION 4: TASK NOT COMPLETED.  The kitchen door, first floor, No.20 - the self closing device requires adjustment to ensure it fully closes this door.
Priority	High
Status	Identified
Owner	Customer Homes
Due Date	28 December 2020

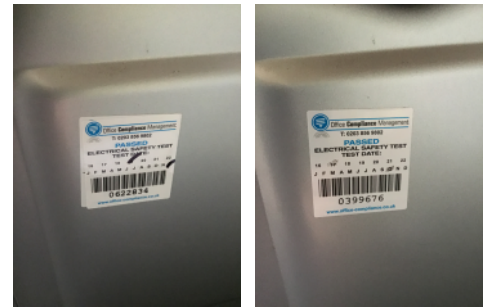
The following portable electrical appliances do not appear to have been recently tested, and should therefore be tested (for testing frequencies, reference should be made to the IEE document In Service Inspection & Testing of Electrical Equipment):

A number of portable electrical appliances in provided in the kitchens do not have evidence of PAT testing.

VERSION 2: The remedial work recommended in Version 1 of this Fire Risk Assessment has not been completed.

VERSION 3: The remedial work recommended in Version 1 of this Fire Risk Assessment been completed. Second photograph provided as evidence.

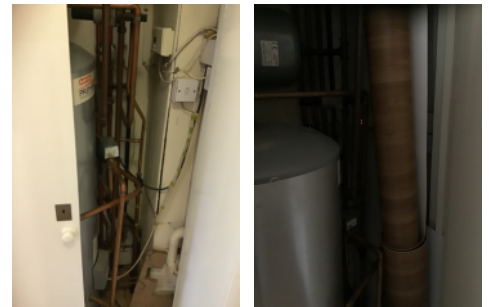
## Task 12

Source Version	2
Category	Fire Prevention
Sub Category	Housekeeping
Action Required	The storage of combustible items in cupboards containing electrical installations should be prohibited.  Combustibles (a roll of vinyl floor covering) is located in the immersion cupboard, directly against electrical installations, in the immersion cupboard on the 1st floor.  VERSION 3: This has been completed, second photograph provided as evidence.
Priority	Medium
Status	Completed
Owner	Neighbourhood Services
Due Date	8 October 2020

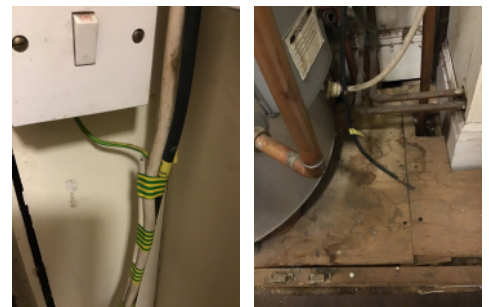
Source Version	1
Category	Fire Prevention
Sub Category	Electrical
Action Required	VERSION 4: NOT COMPLETED  The wiring to the electric water heater in the cupboard on the 1st floor is questionable with a number of loose wires and connections. This should be serviced and tested by a qualified electrical engineer.  VERSION 2: The remedial work recommended in Version 1 of this Fire Risk Assessment has not been completed.  VERSION 3: The remedial work recommended in Version 1 of this Fire Risk Assessment has not been completed.  VERSION 4: The remedial work recommended in Version 1 of this Fire Risk Assessment has not been completed.
Priority	Medium
Status	Identified
Owner	Customer Homes
Due Date	27 February 2019

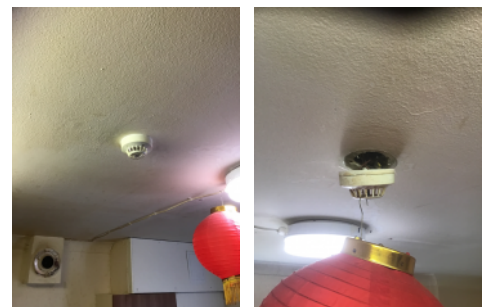
## Task 22

Source Version	2
Category	Detection & Warning
Sub Category	Automatic Fire Detection
Action Required	Repair/replace the heat detector in the kitchen in No.20A.  A lantern has been hung from this, pulling the detector head from the ceiling.  VERSION 3: This task has been completed
Priority	High
Status	Completed
Owner	Customer Homes
Due Date	9 April 2020

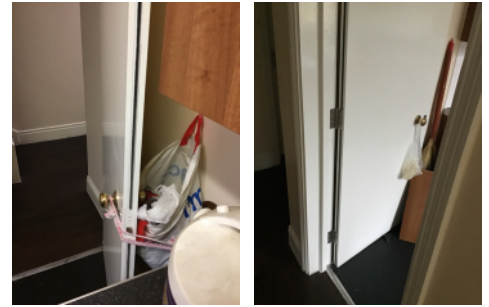
Source Version	1
Category	Escape Routes & Fire Spread
Sub Category	Fire Doors
Action Required	Wedges should not be used to hold open fire doors.

The kitchen door in both No.20 and No.20A was found to be wedged open. These are high risk rooms and both open directly onto the staircase and it is essential they are kept closed at all times.

VERSION 2: The remedial work recommended in Version 1 of this Fire Risk Assessment has not been completed.

VERSION 3: Hold open devices have been installed on these doors.

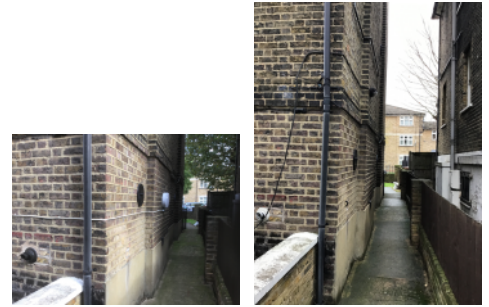
## Task 30

Source Version	1
Category	Emergency Lighting
Sub Category	Normal Lighting
Action Required	Repair the lighting in the following areas:  Rear of building and side access alley.  VERSION 2: This task has been completed. 2nd photograph provided as evidence.
Priority	Medium
Status	Completed
Due Date	27 February 2019

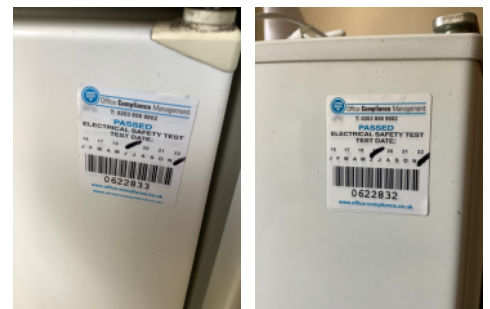
Source Version	4
Category	Fire Prevention
Sub Category	Electrical
Action Required	It is evident that PA testing has not been carried out since the previous fire risk assessment visit. It is recommended that all provided portable electrical appliances are included in a robust testing regime
Priority	Medium
Status	Identified
Owner	Neighbourhood Services
Due Date	22 March 2022
