Fire Risk Assessment

Holland Dwellings

Version 3

8 March 2021

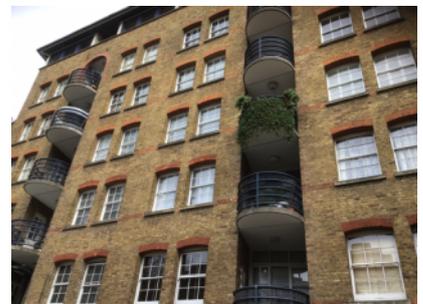
External walls – side elevation.

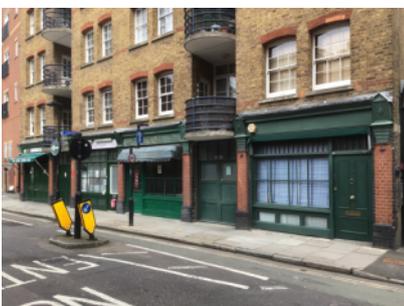
External walls – front elevation

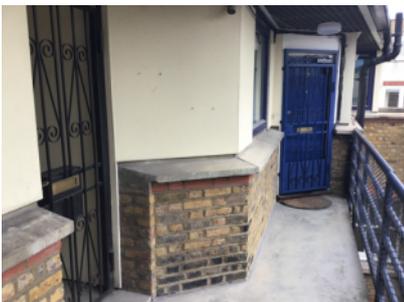
There are security gates across the entrance door to flats 14, 15 and 16.

Security gates across flat entrance doors.

Residents should be advised of the dangers of locked security gates in the event of a fire to ensure that they are able to exit quickly in an emergency.

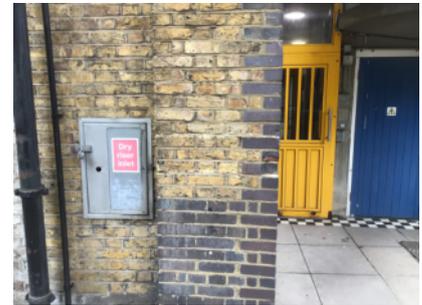
Dry riser inlet provided outside main entrance door.

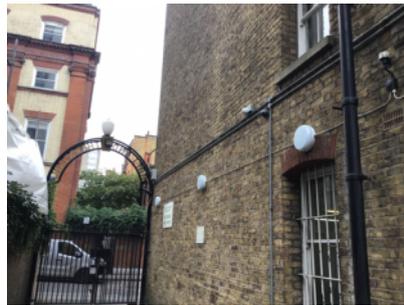
Courtyard lighting.

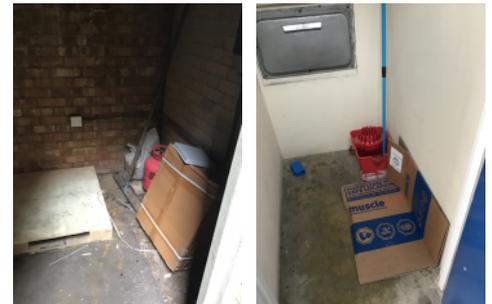
Task 2

Source Version	1
Category	Fire Prevention
Sub Category	Housekeeping
Action Required	Although the amount of combustibles currently in escape routes is not unreasonable, routes should be monitored to ensure the amount of items does not build-up. There were a small amount of combustibles located within the cupboards accessing the rubbish chutes and within the electrical cupboard on the ground floor. The electrical cupboard is located on the ground floor, with direct external access and is imperforate to the escape route and therefore outside of the scope of the FSO, however, it is always advisable to keep electrical cupboards free of combustible items. VERSION 2: Combustibles were still found in these areas at the time of this inspection.
Priority	Advisory
Status	Identified
Owner	Neighbourhood Services
Due Date	29 October 2021

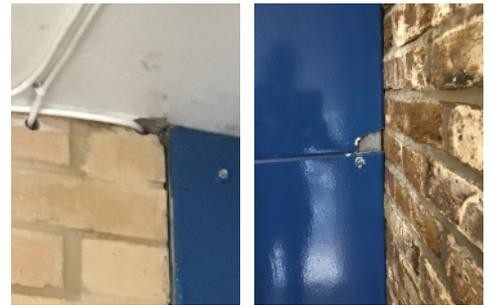
Task 3

There is a riser passing through all floors in the common staircase. This riser is enclosed behind boarding which on inspection may reasonably be assumed to afford adequate fire resistance. However, it is damaged in places and should be repaired in order to maintain the integrity of the common staircase from smoke or fire.

It should also be noted that cable conduit and cable routes pass through the bin store and then into this riser, at a point which is not fire stopped. It is reasonable to assume therefore that any fire in the bin store would easily spread into this shaft. This should be fire stopped.

Source Version	1
Category	Escape Routes & Fire Spread
Sub Category	Construction and Glazing
Action Required	There is a riser passing through all floors in the common staircase. This riser is enclosed behind boarding which on inspection may reasonably be assumed to afford adequate fire resistance. However, it is damaged in places and should be repaired and properly fire stopped in order to maintain the integrity of the common staircase from smoke or fire.
	VERSION 2: This task is yet to be completed.
Priority	Low
Status	Identified
Owner	Customer Homes
Due Date	30 October 2019

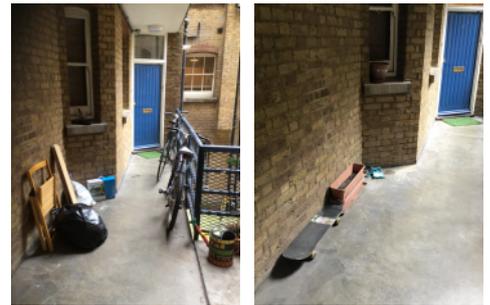
Task 5

Source Version	1
Category	Escape Routes & Fire Spread
Sub Category	Ease of Use
Action Required	<p>VERSION 2 (03.03.2020) The same items are found in the same location at the time of this inspection (outside flats 1 and 2)</p> <p>VERSION 3: the amount of obstructions in this area has increased since the last inspection and therefore the priority for this task has been raised to a medium priority.</p> <p>The first photograph indicates the amount of obstructions in the previous fire risk assessment, the second photograph shows the amount of obstructions located on this common balcony during this inspection.</p>
Priority	Medium
Status	Identified
Owner	Neighbourhood Services
Due Date	30 April 2019

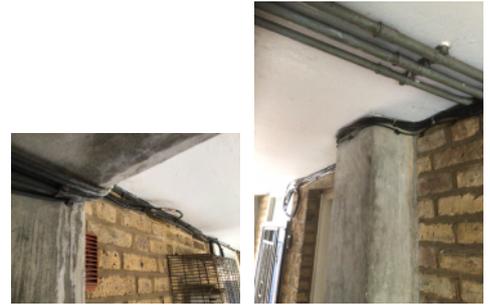
Task 16

There are electrical cables installed in the common parts which are not adequately suspended. A requirement introduced in 2015 in BS 7671 which covers electrical installations in the UK, states that all new wiring systems are to use metal, rather than plastic, to support cables in escape routes, to prevent their premature collapse in the event of a fire. Should any electrical work be carried out in the common areas in the future then it should be ensured that they comply with this requirement.

Source Version	3
Category	Escape Routes & Fire Spread
Sub Category	Ease of Use
Action Required	There are electrical cables installed in the common parts which are not adequately suspended. A requirement introduced in 2015 in BS 7671 which covers electrical installations in the UK, states that all new wiring systems are to use metal, rather than plastic, to support cables in escape routes, to prevent their premature collapse in the event of a fire. Should any electrical work be carried out in the common areas in the future then it should be ensured that they comply with this requirement.
Priority	Advisory
Status	Identified
Owner	Neighbourhood Services
Due Date	8 March 2023
