Islington & Shoreditch Housing Association

25 October 2018

Safety Inspection Report

Site name: **Holland and Thurston, Newton Street, WC2B 5ES**
Date of inspection: **25 October 2018**
Inspector: **David Owen**

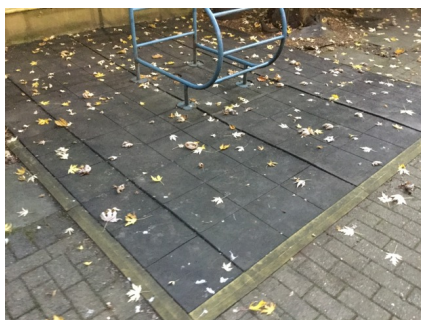
Finding Photos

In the inspector's opinion the protective surface may not meet the head injury criteria requirements from the height required.

- Low

- 4

Refer to manufacturer for comment.
