Fire Risk Assessment

Thurston Dwellings

Version 3

8 March 2021

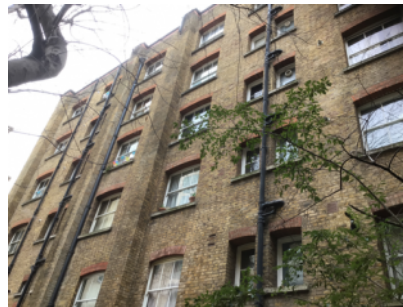
Dry/dead vegetation on the side of the building should be removed

External walls-rear elevation.

There is some dry vegetation on the side face of the building. It appears that this may have been cut and has died, but it has resulted in a dry growth over a number of floors. This may promote floor to floor fire spread in the event of a fire and it is advised to have it completely removed.

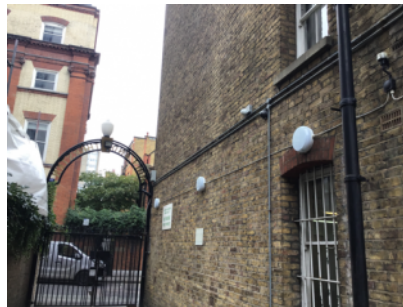
Courtyard lighting.

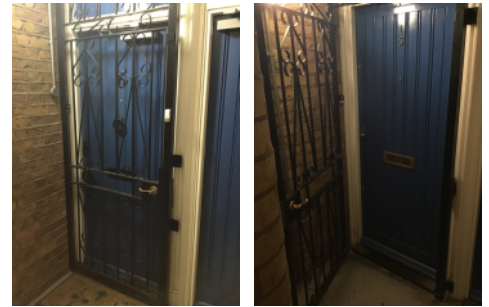
Task 1

There is a security gate across the entrance door to flats 5, 6, 13 and 15.

Source Version	1
Category	Escape Routes & Fire Spread
Sub Category	Ease of Use
Action Required	There is a security gate across the entrance door to flats 5, 6, 13 and 15. Residents should be advised of the dangers of locked security gates in the event of a fire to ensure that they are able to exit quickly in an emergency.
Priority	Advisory
Status	Identified
Owner	Neighbourhood Services
Due Date	29 October 2021

Residents should be advised of the dangers of locked security gates in the event of a fire to ensure that they are able to exit quickly in an emergency.

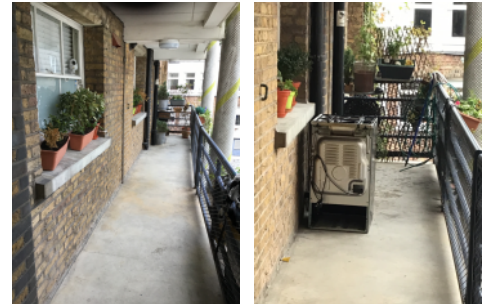
Task 10

Source Version	1
Category	Escape Routes & Fire Spread
Sub Category	Ease of Use
Action Required	Obstructions should be removed from the escape routes in the following locations: Redundant gas cooker outside flat 14. VERSION 2: This has been removed
Priority	Medium
Status	Completed
Due Date	22 January 2019

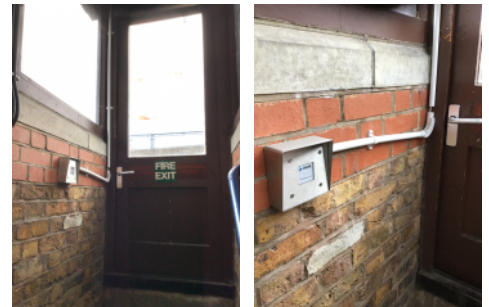
Task 17

There is an alternative escape route on the top floor, over the roof across to a door with an emergency override device fitted, which provides access to the neighbouring Holland Dwellings. However, there is a key fob lock in place on the door out of Thurston Dwellings. This was found to be defective resulting in this door being open, however, it should be removed and replaced with a suitable override device to ensure this door is available for use at all times without the need for a key or fob.

Source Version	2
Category	Escape Routes & Fire Spread
Sub Category	Ease of Use
Action Required	There is an alternative escape route on the top floor, over the roof across to a door with an emergency override device fitted, which provides access to the neighbouring Holland Dwellings. However, there is a key fob lock in place on the door out of Thurston Dwellings. This was found to be defective resulting in this door being open, however, it should be removed and replaced with a suitable override device to ensure this door is available for use at all times without the need for a key or fob.
Priority	Medium
Status	Identified
Owner	Customer Homes
Due Date	1 September 2020

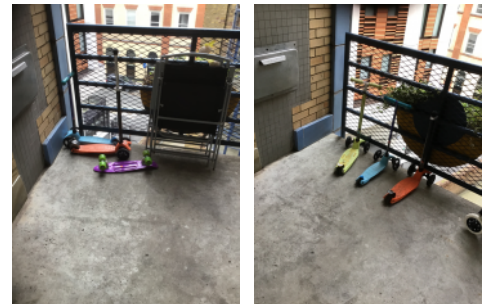
Task 18

Source Version	2
Category	Escape Routes & Fire Spread
Sub Category	Ease of Use
Action Required	Obstructions should be removed from the escape routes in the following locations: Children's scooters located on common balcony of 4th floor. VERSION 3: These same items were found to be present in this location.
Priority	Medium
Status	Identified
Owner	Customer Homes
Due Date	1 September 2020

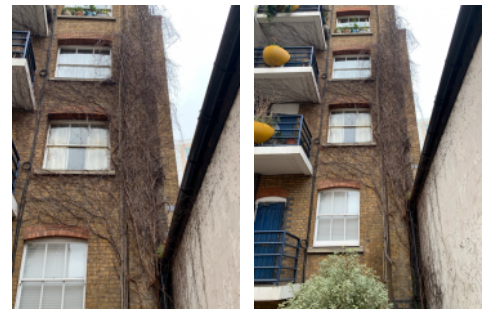
Task 20

Source Version	2
Category	Escape Routes & Fire Spread
Sub Category	Construction and Glazing
Action Required	There is some dry vegetation on the side face of the building. It appears that this may have been cut and has died, but it has resulted in a dry growth over a number of floors. This may promote floor to floor fire spread in the event of a fire and it is advised to have it completely removed.
Priority	Low
Status	Identified
Owner	Customer Homes
Due Date	3 March 2021
