**Fire Risk Assessment**

**21-32 St Mary's House**

Version 3

4 December 2020

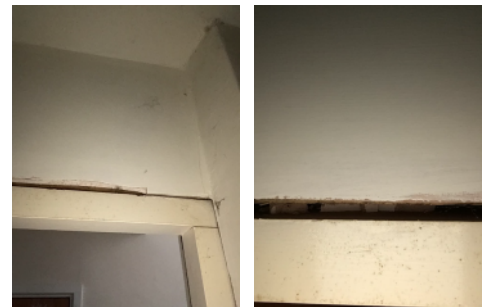
Source Version	1
Category	Escape Routes & Fire Spread
Sub Category	Construction and Glazing
Action Required	Provide fire stopping around the door frame at the following locations:  Inside the ground floor electric meter cupboard at the top of the doorframe.  VERSION 2: The recommended remedial work in this task has not been completed.
Priority	Medium
Status	Identified
Owner	Customer Homes
Due Date	11 February 2019

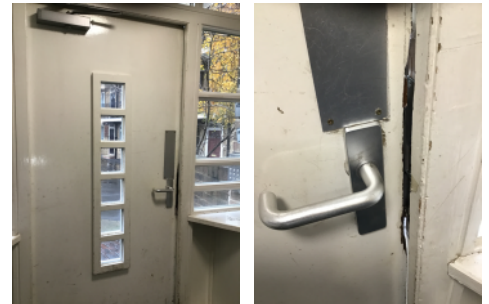
Source Version	2
Category	Fire Prevention
Sub Category	Arson
Action Required	Provide security control to the main entrance door, repair locks.
Priority	Medium
Status	Identified
Owner	Customer Homes
Due Date	9 December 2020

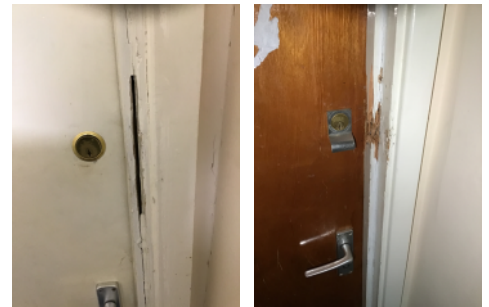
Source Version	2
Category	Escape Routes & Fire Spread
Sub Category	Fire Doors
Action Required	Repair the door frame to flat 28.  Repair the door frame to flat 25.  Electrical cupboard, lower ground floor.
Priority	Medium
Status	Identified
Owner	Customer Homes
Due Date	9 December 2020
