**Fire Risk Assessment**

**20 and 20A Ainsworth Road**

Version 3

30 September 2020

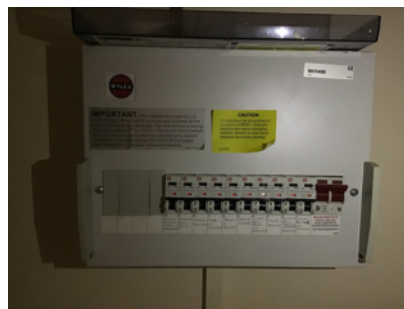
Consumer unit, 2nd floor in No.20

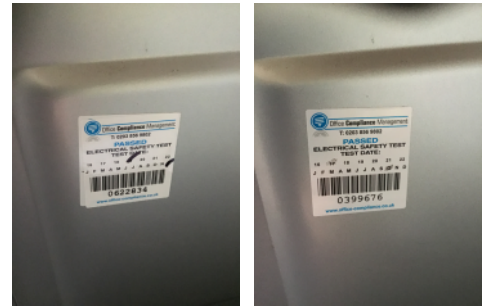
The following portable electrical appliances do not appear to have been recently tested, and should therefore be tested (for testing frequencies, reference should be made to the IEE document In Service Inspection & Testing of Electrical Equipment):

A number of portable electrical appliances in provided in the kitchens do not have evidence of PAT testing.

VERSION 2: The remedial work recommended in Version 1 of this Fire Risk Assessment has not been completed.

VERSION 3: The remedial work recommended in Version 1 of this Fire Risk Assessment been completed. Second photograph provided as evidence.

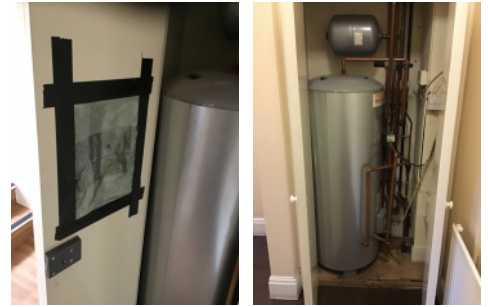
VERSION 2: This task has been remedied by cutting out the inner face of the door, allowing the door to close. However, in doing this it has severely compromised the fire resistance of this door. This door should now be replaced (to FD30S) and the whole cupboard extended in order to accommodate the boiler/immersion correctly.

VERSION 3: The remedial work recommended previous versions of this Fire Risk Assessment has not been completed.

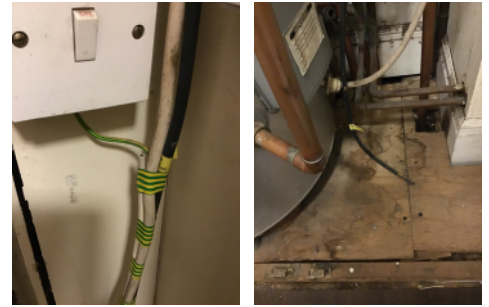
The wiring to the electric water heater in the cupboard on the 1st floor is questionable with a number of loose wires and connections. This should be serviced and tested by a qualified electrical engineer.

VERSION 2: The remedial work recommended in Version 1 of this Fire Risk Assessment has not been completed.

VERSION 3: The remedial work recommended in Version 1 of this Fire Risk Assessment has not been completed.

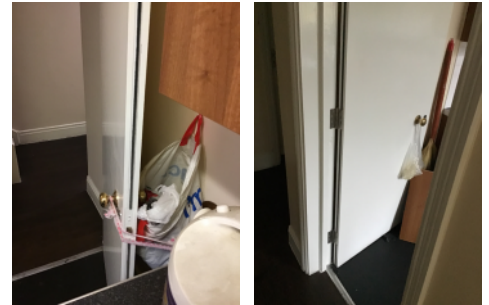
The kitchen door in both No.20 and No.20A was found to be wedged open. These are high risk rooms and both open directly onto the staircase and it is essential they are kept closed at all times.

VERSION 2: The remedial work recommended in Version 1 of this Fire Risk Assessment has not been completed.

VERSION 3: Hold open devices have been installed on these doors.

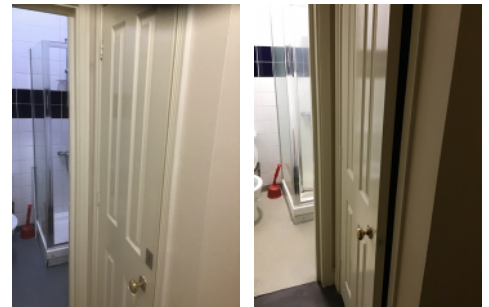
Replace the following doors with FD30S doors:

VERSION 2: The remedial work recommended in the previous FRA has not been completed.

VERSION 3: The remedial work recommended in the previous FRA has not been completed.

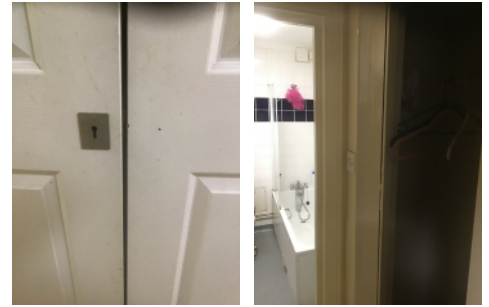
The intumescent strips and smoke seals on the following doors have been over-painted and should be replaced:

VERSION 2: The remedial work recommended in the previous FRA has not been completed. This door is also damaged on the inner face. It is recommended to replace these doors with FD30S doors.

VERSION 3: This task has not been completed.

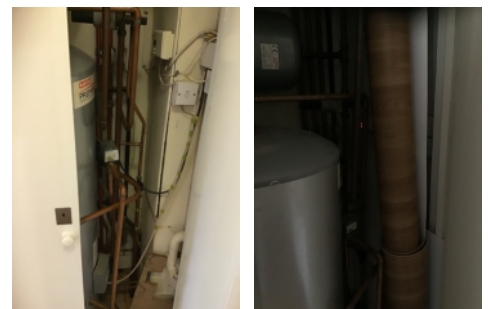
Source Version	2
Category	Fire Prevention
Sub Category	Housekeeping
Action Required	The storage of combustible items in cupboards containing electrical installations should be prohibited.  Combustibles (a roll of vinyl floor covering) is located in the immersion cupboard, directly against electrical installations, in the immersion cupboard on the 1st floor.  VERSION 3: This has been completed, second photograph provided as evidence.
Priority	Medium
Status	Completed
Owner	Neighbourhood Services
Due Date	8 October 2020

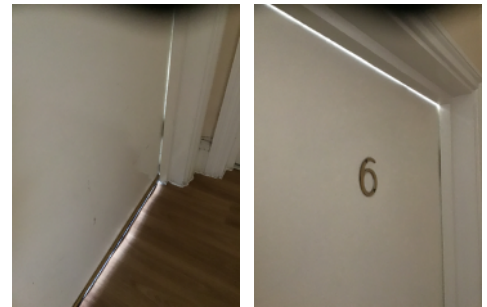
Source Version	2
Category	Escape Routes & Fire Spread
Sub Category	Fire Doors
Action Required	NOT COMPLETED
	Re-hang the following doors to reduce the gaps around the doors:
	External examination only of the door to Room 6 revealed it does not fit the frame correctly, with excessive gaps showing.
	VERSION 3: The remedial work recommended in previous versions of this Fire Risk Assessment has not been completed.
Priority	Medium
Status	Identified
Owner	Customer Homes
Due Date	8 October 2020

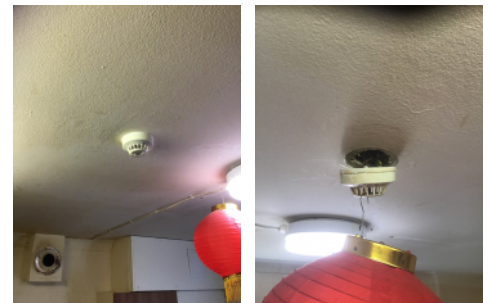
Source Version	2
Category	Detection & Warning
Sub Category	Automatic Fire Detection
Action Required	Repair/replace the heat detector in the kitchen in No.20A.  A lantern has been hung from this, pulling the detector head from the ceiling.  VERSION 3: This task has been completed
Priority	High
Status	Completed
Owner	Customer Homes
Due Date	9 April 2020

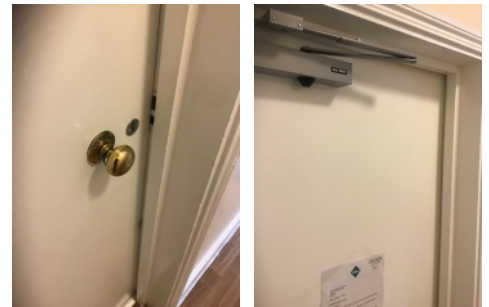
Source Version	3
Category	Escape Routes & Fire Spread
Sub Category	Fire Doors
Action Required	The kitchen door, first floor, No.20 - the self closing device requires adjustment to ensure it fully closes this door.
Priority	High
Status	Identified
Owner	Customer Homes
Due Date	28 December 2020

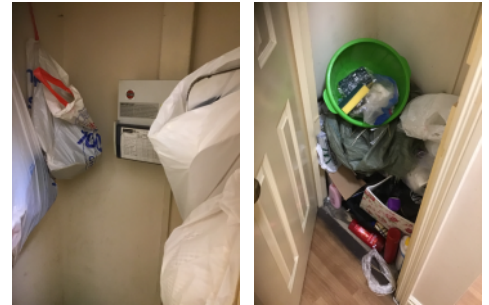
Source Version	3
Category	Fire Prevention
Sub Category	Housekeeping
Action Required	The storage of combustible items in electrical cupboards should be prohibited.  (No.20A, first floor)
Priority	Medium
Status	Identified
Owner	Neighbourhood Services
Due Date	31 March 2021
