Fire Risk Assessment

Burbage House

Version 4

20 January 2021

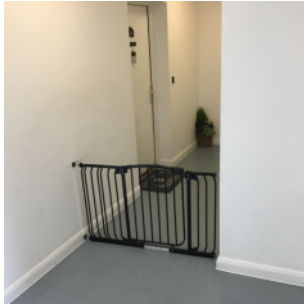
There is a baby gate on the 4th floor landing which could present a trip hazard to the occupants of flat 14. This does not affect any other residents so could be considered as reasonable.

Baby gate leading to flat 14
