Fire Risk Assessment

1 Dunston Road

Version 7

1 December 2022

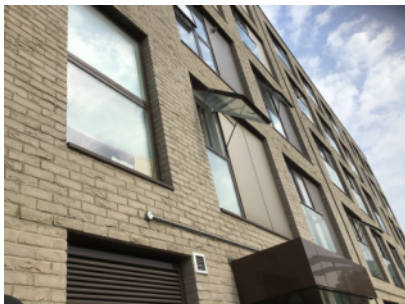
FRONT OF BUILDING : Visual inspection only - Brick external wall system

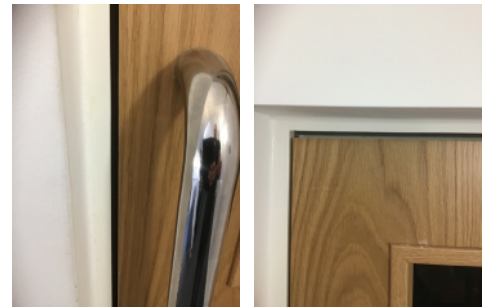
Task 2

Source Version	3
Category	Escape Routes & Fire Spread
Sub Category	Fire Doors
Action Required	Re-hang the following doors to reduce the gaps around the doors: Staircase door, 2nd floor. This door has an excessive top gap (12mm) and an excessive latch edge gap (10mm) which should be reduced. Version 6. 22/9/22 This task is not complete. Version 7- 01/12/2022 Not yet actioned.
Priority	Medium
Status	Identified
Owner	Customer Homes
Due Date	23 March 2021

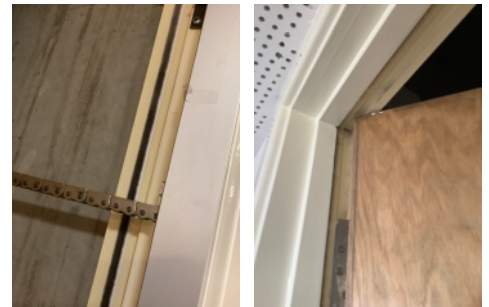
Task 8

Source Version	5
Category	Escape Routes & Fire Spread
Sub Category	Fire Doors
Action Required	Install intumescent strips and smoke seals on the following doors: All smoke shaft doors Version 6. 22/9/22 This task is complete.
Priority	Medium
Status	Completed
Owner	Customer Homes
Due Date	8 February 2022

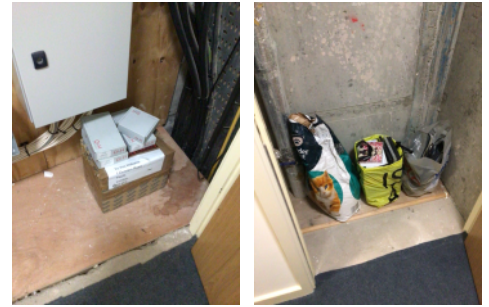
Task 14

Source Version	7
Category	Fire Prevention
Sub Category	Housekeeping
Action Required	The storage of combustible items in riser cupboards should be prohibited. 1st floor water riser cupboard. 1st floor electrical riser cupboard.
Priority	Medium
Status	Identified
Owner	Neighbourhood Services
Due Date	1 June 2023
