**Fire Risk Assessment**

**2 Dunston Road**

Version 7

1 December 2022

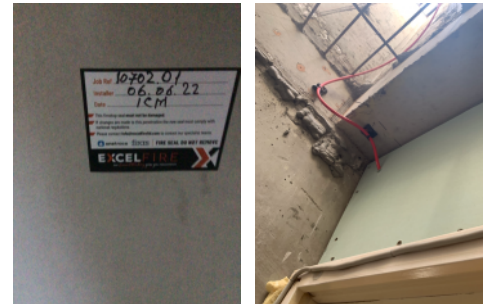
Action Required **VERSION 3:** The following task was found to have not been completed. Access was again made into the smoke shaft, where it is evident penetrations without fire stopping are present.

The smoke shaft door on the 5th floor was tested during this inspection. When this door was in the open position, it was evident that cabling within the smoke shaft penetrating into the common corridor has not been fire stopped. It is reasonable to assume that this would be the case on all other floors. This should be fire stopped at each level to ensure the integrity and fire separation between the shaft and the common areas.

Provide fire stopping around cable penetrations in the following locations:

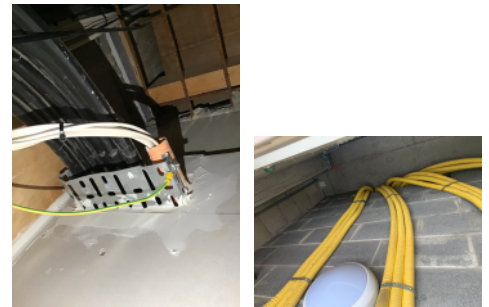
These have either no fire stopping installed, or fire stopping which has been installed to an unacceptable standard. These penetrations should be fire stopped using methods and materials suitable to such penetration sizes in line with current industry recommendations, and Approved Document B, Volume 2, Section 10 - "Protection of Openings and Fire Stopping"

These have been identified within this report with recommendation to carry out fire stopping remedial work to ensure adequate fire separation is in place to protect scale routes and prevent fire spread between flats and common parts of the building. Considering the number of penetrations identified within the scope of this Fire Risk Assessment, it is recommended that a full compartmentation survey is carried out throughout this building.

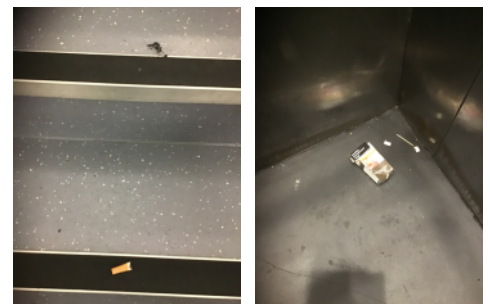
Source Version	3
Category	Fire Prevention
Sub Category	Smoking
Action Required	<p>A no smoking policy should be enforced in the premises.</p> <p>Evidence of smoking and smoking materials were found in the lift car, and on the staircase.</p>
Priority	Medium
Status	Completed
Owner	Neighbourhood Services
Due Date	23 March 2021

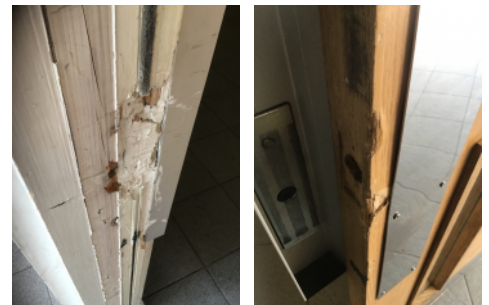
Source Version	3
Category	Escape Routes & Fire Spread
Sub Category	Fire Doors
Action Required	There is extensive damage to the door and door frame to the ground floor lobby, possibly due to forced entry. This should be repaired or replaced to an FD30S SC standard of fire resistance.  Version 7- 01/12/2022 Not yet actioned.
Priority	High
Status	Identified
Owner	Customer Homes
Due Date	21 December 2020

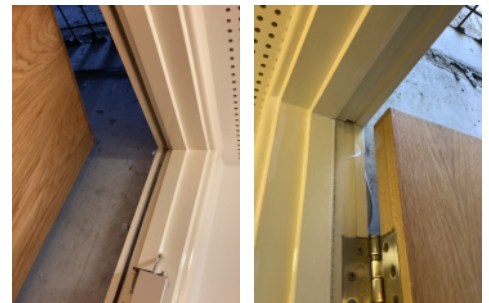
Source Version	5
Category	Escape Routes & Fire Spread
Sub Category	Fire Doors
Action Required	Install intumescent strips and smoke seals on the following doors:  Smoke shaft doors
	Version 6. 22/9/22 This task is complete.
Priority	Medium
Status	Completed
Owner	Customer Homes
Due Date	8 February 2022

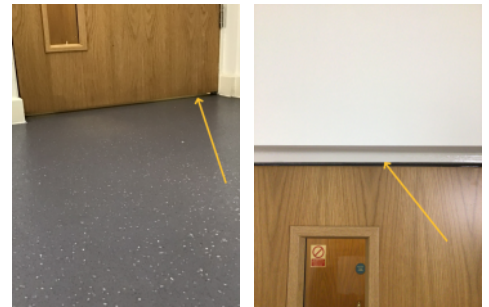
Source Version	5
Category	Escape Routes & Fire Spread
Sub Category	Fire Doors
Action Required	Re-hang the following doors to reduce the threshold gaps around the doors:  3rd 4th, 5th floor staircase doors  Version 6. 22/9/22 This task is not complete.  Version 7- 01/12/2022 Not yet actioned.
Priority	Low
Status	Identified
Owner	Customer Homes
Due Date	11 August 2022

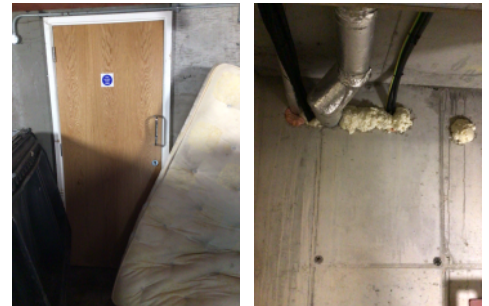
Source Version	7
Category	Escape Routes & Fire Spread
Sub Category	Construction and Glazing
Action Required	Provide fire stopping at the following locations: Pipe penetrations within the mezzanine tank room, accessed above bin store.
Priority	Medium
Status	Identified
Owner	Customer Homes
Due Date	1 June 2023

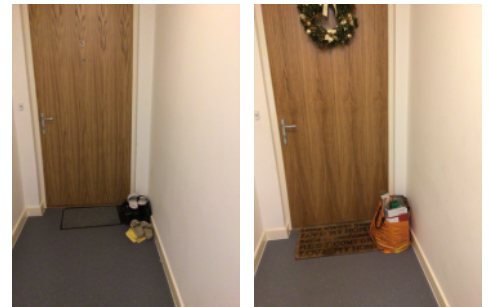
Source Version	7
Category	Fire Prevention
Sub Category	Housekeeping
Action Required	The storage of combustible items in escape routes should be prohibited.  Outside flat 12. Outside flat 3.
Priority	Medium
Status	Identified
Owner	Neighbourhood Services
Due Date	1 June 2023

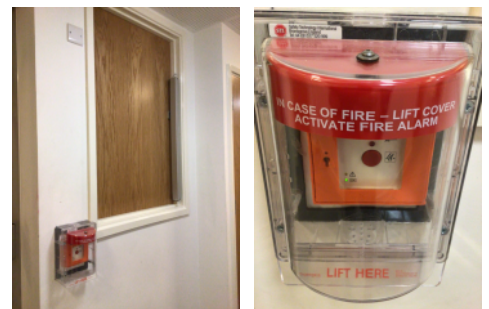
Source Version	7
Category	Signs & Notices
Sub Category	Other Signage
Action Required	Covers used to protect the smoke ventilation controls in corridors and the staircase are incorrectly marked as activating the fire alarm (there is no common alarm present). The wording should be amended to refer to the operation of the smoke vent doors or alternatively the wording removed completely as the operation of AOV is not normally for resident use.
Priority	Medium
Status	Identified
Owner	Customer Homes
Due Date	1 June 2023
