**Fire Risk Assessment**

**50 Acton Mews**

Version 7

1 December 2022

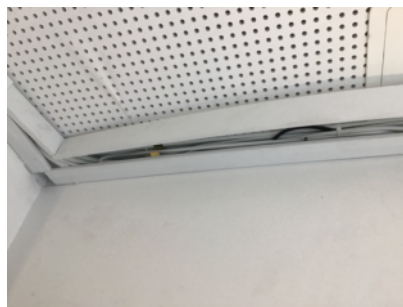
Electrical cabling is affixed to the ceiling in the entrance hallway within plastic trunking. This could fail in a fire and cause the cabling to fall across doorways and staircases presenting a serious trip or entanglement hazard. A requirement introduced in 2015 in BS 7671 which covers electrical installations in the UK, states that all new wiring systems to use metal, rather than plastic, to support cables in escape routes, to prevent their premature collapse in the event of a fire. It is advised that this cabling is supported with metal fixings as opposed to the plastic fixings which are in place.

Cable runs in plastic trunking above staircase door.

Showing cables within plastic ducting affixed to the ceiling in common area

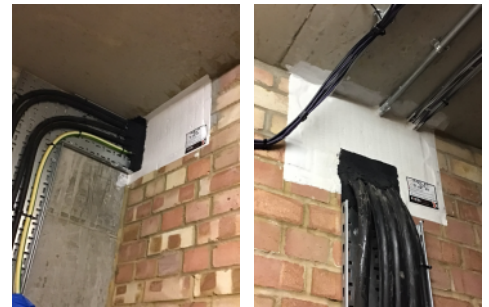
## Task 2

Source Version	2
Category	Escape Routes & Fire Spread
Sub Category	Construction and Glazing
Action Required	Provide fire stopping around cable penetrations in the following locations:  Within the CCTV room

It was not possible to access the area to determine if this task is complete. It should be confirmed that this work has been completed.

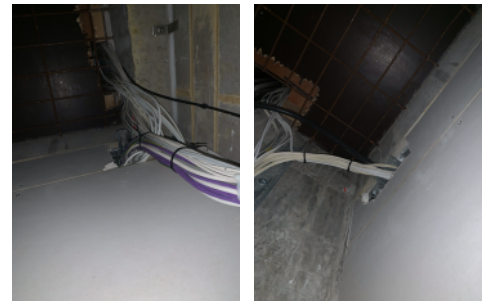
## Task 3

Source Version	2
Category	Escape Routes & Fire Spread
Sub Category	Construction and Glazing
Action Required	Provide fire stopping around cable penetrations in the following locations:  Within the BT / data cupboard adjacent to the lift.

This task is not complete.

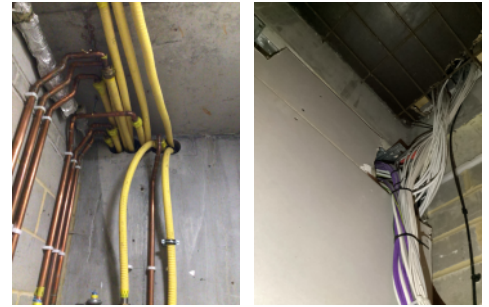
## Task 10

Source Version	1
Category	Escape Routes & Fire Spread
Sub Category	Construction and Glazing
Action Required	There are a number of cable and pipe penetrations into common areas of the building from riser cupboards, gas intake cupboards, the bin store and bike store which present a high risk of smoke and fire spread in the event of a fire.

These have either no fire stopping installed, or fire stopping which has been installed to an unacceptable standard. These penetrations should be fire stopped using methods and materials suitable to such penetration sizes in line with current industry recommendations, and Approved Document B, Volume 2, Section 10 - "Protection of Openings and Fire Stopping"

These have been identified within this report with recommendation to carry out fire stopping remedial work to ensure adequate fire separation is in place to protect scale routes and prevent fire spread between flats and common parts of the building. Considering the number of penetrations identified within the scope of this Fire Risk Assessment, it is recommended that a full compartmentation survey is carried out throughout this building.

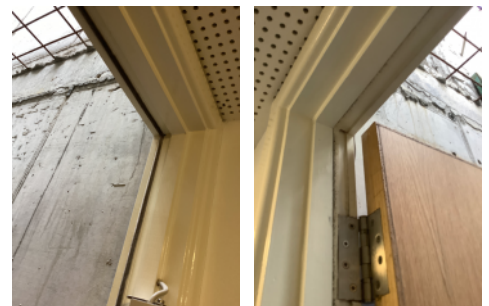
## Task 12

Source Version	5
Category	Escape Routes & Fire Spread
Sub Category	Fire Doors
Action Required	Install intumescent strips and smoke seals on the following doors:  Smoke shaft doors
	Version 6. 22/9/22 This task is complete.
Priority	Medium
Status	Completed
Owner	Customer Homes
Due Date	8 February 2022

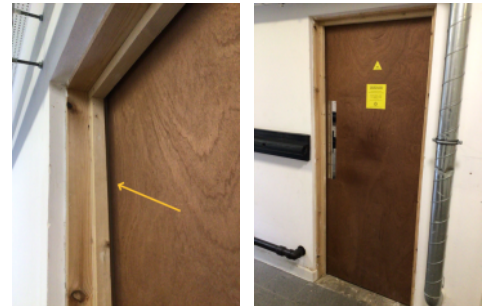
## Task 18

Source Version	7
Category	Escape Routes & Fire Spread
Sub Category	Fire Doors
Action Required	Adjust the self-closing device on the following doors:  Ground floor gas meter room. Door not closing fully against stops.
Priority	Medium
Status	Identified
Owner	Customer Homes
Due Date	1 June 2023

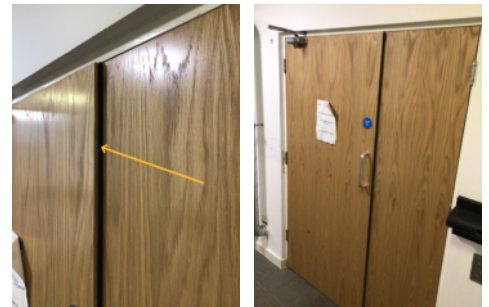
Source Version	7
Category	Escape Routes & Fire Spread
Sub Category	Fire Doors
Action Required	Re-hang the following doors to enable the doors to easily close: Internally accessed bin store.
Priority	Medium
Status	Identified
Owner	Customer Homes
Due Date	1 June 2023

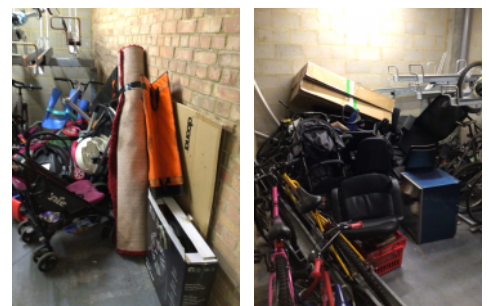
Source Version	7
Category	Fire Prevention
Sub Category	Housekeeping
Action Required	The storage of combustible items in communal areas is excessive and should be reduced.  Items in bike store.
Priority	Medium
Status	Identified
Owner	Neighbourhood Services
Due Date	1 June 2023

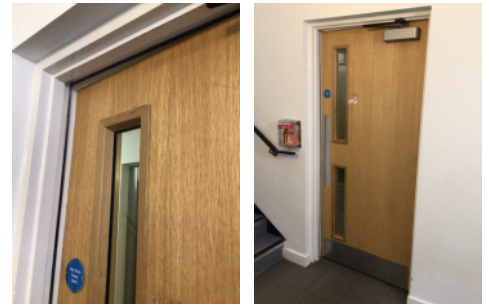
Source Version	7
Category	Escape Routes & Fire Spread
Sub Category	Fire Doors
Action Required	Re-hang the following doors to enable the doors to easily close:  Ground floor lift lobby door. Not closing and leaving large gaps.
Priority	High
Status	Identified
Owner	Customer Homes
Due Date	1 March 2023

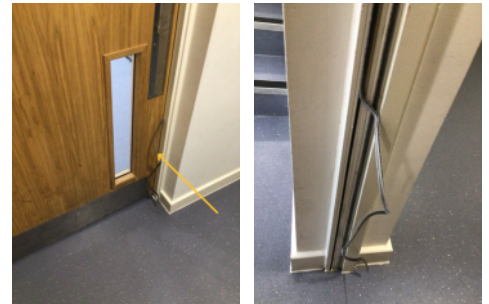
Source Version	7
Category	Escape Routes & Fire Spread
Sub Category	Fire Doors
Action Required	The intumescent strips and smoke seals on the following doors are damaged and should be replaced:  1st floor staircase lobby door.
Priority	Medium
Status	Identified
Owner	Customer Homes
Due Date	1 June 2023
