## **Fire Risk Assessment**

### **West Central Apartments, 1-35**

Version 6

10 July 2023

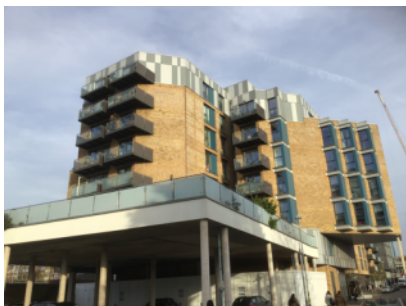
Underside of private balconies

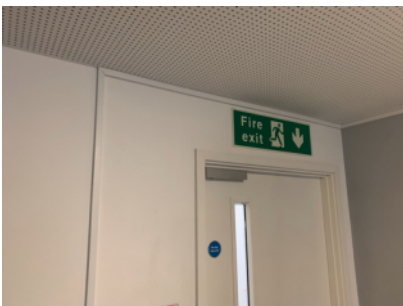
Example of PVCu cable conduit over staircase door.

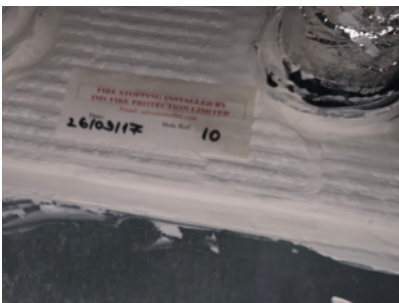
Example of fire stopping certification label - IMS Fire Protection Ltd 2017

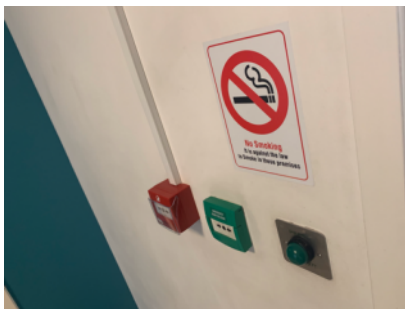
Manual call points located at each floor exit

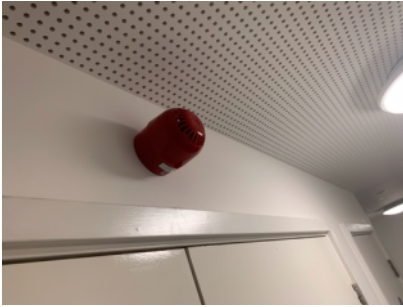
Sounders located in common areas.

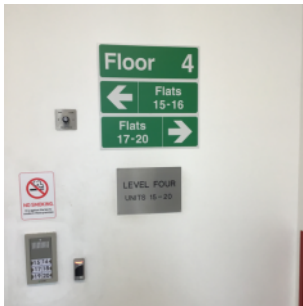
New wayfinding signage has been provided

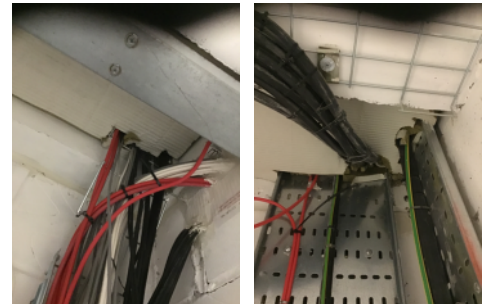
Source Version	1
Category	Escape Routes & Fire Spread
Sub Category	Construction and Glazing
Action Required	Provide fire stopping around cable penetrations in the following locations:  Within the electrical risers, located within corridors to flats, there has been some fire stopping installed, although it is inadequate with holes and gaps.  Version 4 - This task is still outstanding.  Version 5. 27/9/22 This task is not complete.
Priority	Medium
Status	Identified
Owner	Customer Homes
Due Date	21 November 2020

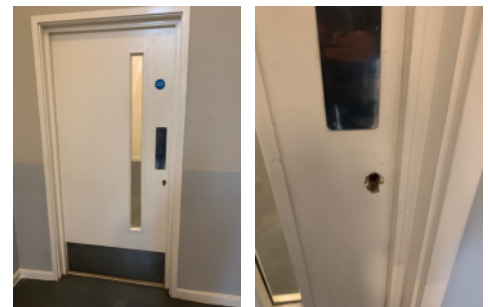
Source Version	1
Category	Escape Routes & Fire Spread
Sub Category	Fire Doors
Action Required	Repair the following doors to an FD30S self-closing standard:  The plant room door on the ground floor has a hole which should be repaired to maintain its fire resisting integrity.
	Version 4 - This task is still outstanding.
	Version 5. 27/9/22 This task is not complete.
Priority	Low
Status	Identified
Owner	Customer Homes
Due Date	21 November 2021

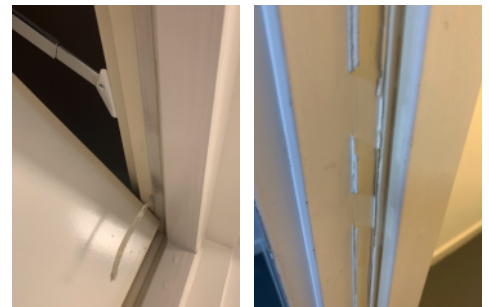
Source Version	1
Category	Escape Routes & Fire Spread
Sub Category	Fire Doors
Action Required	Neoprene type smoke seals have been installed in many of the fire resisting doors in common areas, and in flat front doors. These do not wear well and there are many which are already damaged or missing. A task has been generated, however with the presence of a common fire detection and alarm system provided in the building this task has been entered as advisory.  Version 5. 27/9/22 It is noted that many of these seals are damaged.
Priority	Advisory
Status	Identified
Owner	Customer Homes
Due Date	21 November 2022

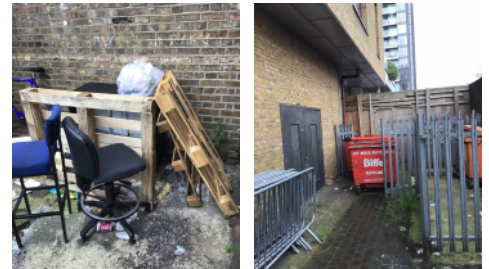
Source Version	4
Category	Fire Prevention
Sub Category	Arson
Action Required	Do not keep bins adjacent to the building, they should be secured in the compound provided and clear the rubbish from the rear yard to reduce the risk of malicious ignition.  Version 5. 27/9/22 This task is not complete.
Priority	High
Status	Identified
Owner	Neighbourhood Services
Due Date	8 February 2022

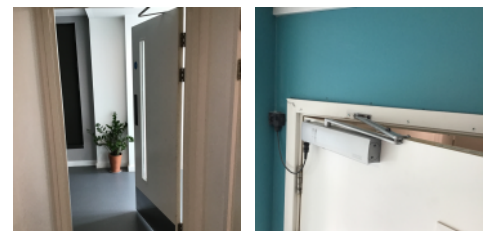
Source Version	6
Category	Escape Routes & Fire Spread
Sub Category	Fire Doors
Action Required	Repair the self-closing device on the following doors:  The 7th Floor fire door to Flats 32-35 has a free swing device fitted but the self closer is defective.
Priority	High
Status	Identified
Owner	Customer Homes
Due Date	8 October 2023
