Fire Risk Assessment

43-68 Belvedere Court

Version 7

5 July 2023

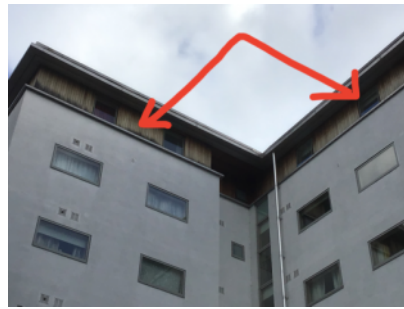
Showing timber cladding fitted on the sixth floor external walls.

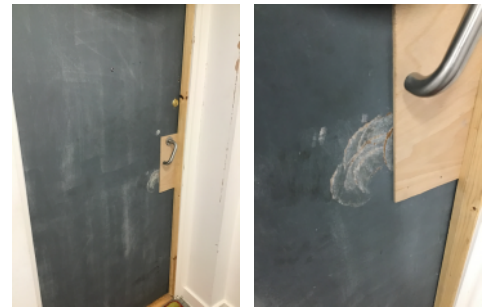
Task 5

Access could not be gained into flat 52, however the flat entrance door has obviously been subjected to some severe force, possibly forced entry, which has caused considerable damage. A temporary repair has been made, however it is evident that this door would no longer afford the required FD30S SC standard of fire resistance and it should be repaired or replaced to that standard.

Source Version	1
Category	Escape Routes & Fire Spread
Sub Category	Fire Doors
Action Required	Repair or replace the flat entrance door to flat 52 to an FD30S SC standard of fire resistance. Version 6. 14/9/22 This task is not yet complete.
Priority	Medium
Status	Identified
Owner	Customer Homes
Due Date	4 September 2020

5	Escape Routes & Fire Spread	Fire Doors	Repair or replace the flat entrance door to flat 52 to an FD30S SC standard of fire resistance. Version 6. 14/9/22 This task is not yet complete.	Medium	Identified
---	-----------------------------	------------	---	--------	------------

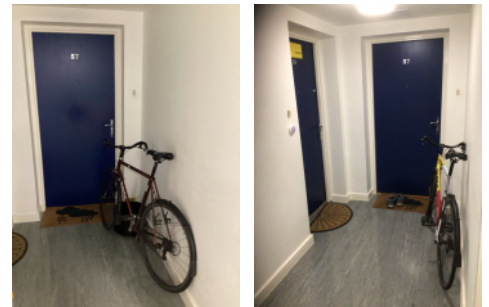
Task 7

Source Version	4
Category	Escape Routes & Fire Spread
Sub Category	Ease of Use
Action Required	Bikes should not be stored as to obstruct escape routes. (Located outside flat 57) Version 6. 14/9/22 This task is not yet complete.
Priority	Medium
Status	Identified
Owner	Neighbourhood Services
Due Date	3 August 2021

7	Escape Routes & Fire Spread	Ease of Use	<p>Bikes should not be stored as to obstruct escape routes.</p> <p>(Located outside flat 57)</p> <p>Version 6. 14/9/22 This task is not yet complete.</p>	Medium	Identified
8	Signs & Notices	Other Signage	<p>It is imperative that the correct fire action notice is provided and that all residents are fully briefed and fully understand the move to a simultaneous evacuation strategy and the actions that they should take in the event of hearing a fire alarm or discovering a fire in the building.</p> <p>Version 6. 14/9/22 This task is not yet complete.</p>	High	Identified
9	Fire Prevention	Housekeeping	<p>Whilst beyond the scope of the Fire Safety Order, as a private balcony is not part of the common area, residents should be advised about the risks arising from the presence of combustible materials on balconies. They should make clear that smoking, the use of barbecues and storage of flammable property on balconies can increase that risk. Advice from fire and rescue authorities is also clear that barbecues should not be used on balconies.</p> <p>(MHCLG Advice Note on Balconies on Residential Buildings, 2019)</p>	Advisory	Identified

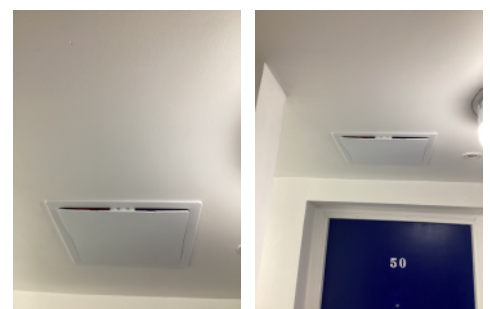
Task 13

Source Version	6
Category	Escape Routes & Fire Spread
Sub Category	Construction and Glazing
Action Required	It is noted that new access panels in the common area ceilings do not appear to be of 30 minute fire resisting construction.
Priority	Medium
Status	Identified
Owner	Customer Homes
Due Date	14 March 2023
