Fire Risk Assessment

Flats 1 – 15, 48 Grenville Road

Version 4

3 October 2023

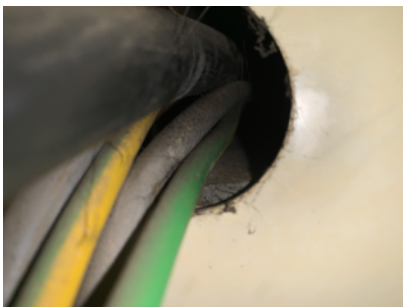
As these meters measure residents electrical consumption it may be reasonably assumed that this exposes the potential for smoke/fire spread between flats and the common staircase and should therefore be properly fire stopped.

It is also noted that these meter cupboards are uPVC construction and are not suitable for use within internal staircases and lobbies. It is recommended to replace these cabinets with ones which are suitably fire rated.

Penetrations from meter cupboards (not FR) on staircases into risers.

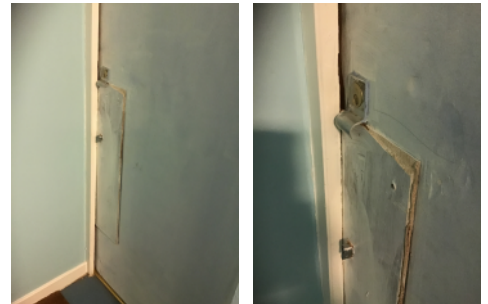
Task 1

The flat entrance door to flat 3 (not accessed) appears to have a temporary repair, possibly filling damage caused by forced access. It is evident that this has compromised the fire resistance of this door and this should be replaced with one which affords an FD30S SC standard of fire resistance.

The flat entrance door to flat 3 remains in a severely damaged condition and should be replaced. This was highlighted in previous FRAs and this door has been in this condition for some time.

Source Version	2
Category	Escape Routes & Fire Spread
Sub Category	Fire Doors
Action Required	The flat entrance door to flat 3 (not accessed) appears to have a temporary repair, possibly filling damage caused by forced access. It is evident that this has compromised the fire resistance of this door and this should be replaced with one which affords an FD30S SC standard of fire resistance.

VERSION 3: This task has not been completed at the time of this inspection. Access was gained into this flat where it was noted that neither the door leaf or door frame are to an acceptable standard, and damage to both has rendered it to below the standard of fire resistance required for a flat entrance door. This door set should be replaced with one which affords at least an FD30S SC standard of fire resistance.

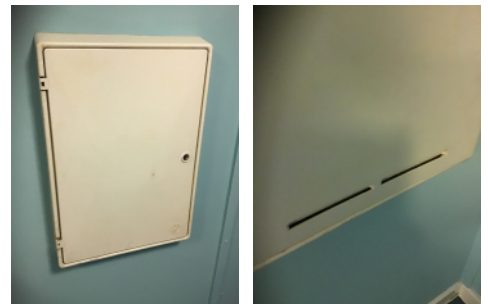
Task 2

Source Version	2
Category	Escape Routes & Fire Spread
Sub Category	Construction and Glazing
Action Required	The provided electrical meter cupboards are uPVC construction and are not suitable for use within internal staircases and lobbies. It is recommended to replace these cabinets with ones which are suitably fire rated.

VERSION 3: This task has not been completed at the time of this inspection

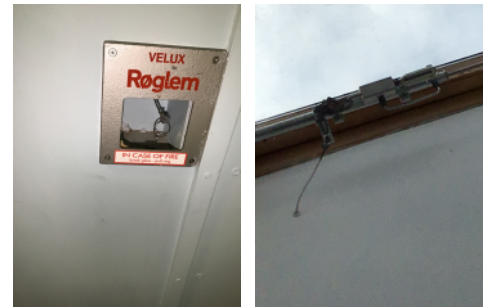
Task 5

The “Velux” skylight at the top of the staircase is manually operated via a break-glass pull ring system. It was observed that the break-glass on the lower ground floor is broken and the system had been accessed.

Also, visual examination of the mechanism on the velux window raises concern as to its serviceability. It is recommended that this system is tested and the break-glass replaced to ensure it will operate correctly in the event of an emergency.

Source Version	1
Category	Escape Routes & Fire Spread
Sub Category	Smoke Ventilation
Action Required	<p>The “Velux” skylight at the top of the staircase is manually operated via a break-glass pull ring system. It was observed that the break-glass on the lower ground floor had been accessed.</p> <p>Also, visual examination of the mechanism on the velux window raises concern as to its serviceability. It is recommended that this system is tested and the break-glass replaced to ensure it will operate correctly in the event of an emergency.</p> <p>VERSION 2: This task has not been completed at the time of this inspection</p> <p>VERSION 3: This task has not been completed at the time of this inspection</p>
Priority	High
Status	Identified
Owner	Customer Homes
Due Date	17 November 2019
