**Fire Risk Assessment**

**1-16 Penn Street**

Version 7

12 October 2023

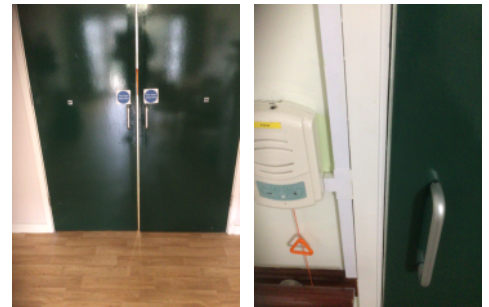
Source Version	5
Category	Escape Routes & Fire Spread
Sub Category	Fire Doors
Action Required	Re-hang the following doors to reduce the gaps around the doors:  Dining room door.  Cross-corridor door adjacent flat 1  Version 6. 21/9/22 This task is not complete
Priority	Medium
Status	Identified
Owner	Customer Homes
Due Date	14 September 2021

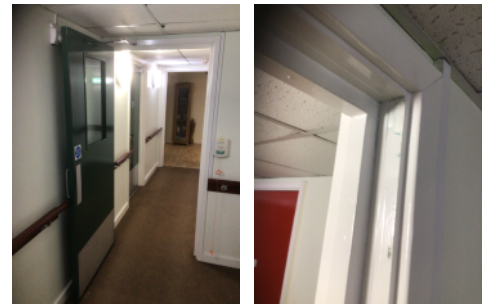
## Task 10

Source Version	5
Category	Escape Routes & Fire Spread
Sub Category	Fire Doors
Action Required	Install intumescent strips and smoke seals on the following doors:  Cross corridor door through to the kitchen and dining room area on the ground floor.  Version 6. 21/9/22 This task is not complete.
Priority	Medium
Status	Identified
Owner	Customer Homes
Due Date	14 September 2021

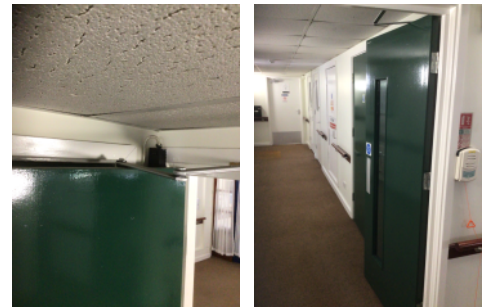
## Task 11

Source Version	5
Category	Escape Routes & Fire Spread
Sub Category	Fire Doors
Action Required	Repair the free-swing device on the following doors:  Cross corridor door to the corridor serving the laundry area on the ground floor.  Version 6. 21/9/22 This task is not complete.
Priority	High
Status	Identified
Owner	Customer Homes
Due Date	14 June 2021

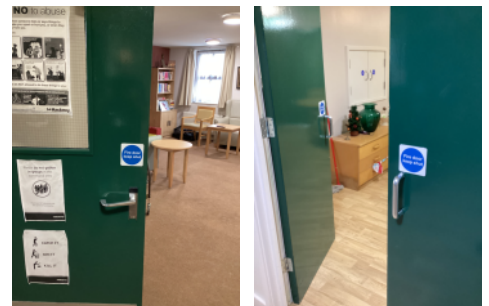
Source Version	6
Category	Signs & Notices
Sub Category	Fire Door Signage
Action Required	Provide Automatic Fire Door Keep Clear signs on the following doors:  entrance to lounge from corridor,  double doors to ground floor office  Door from corridor into lounge  Double doors from small to large dining areas
Priority	Low
Status	Identified
Owner	Customer Homes
Due Date	21 September 2023

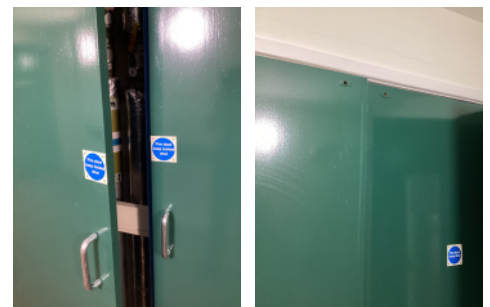
## Task 17

Source Version	6
Category	Escape Routes & Fire Spread
Sub Category	Fire Doors
Action Required	The following doors should be kept locked shut: riser cupboard second floor
Priority	Medium
Status	Identified
Owner	Neighbourhood Services
Due Date	22 March 2023

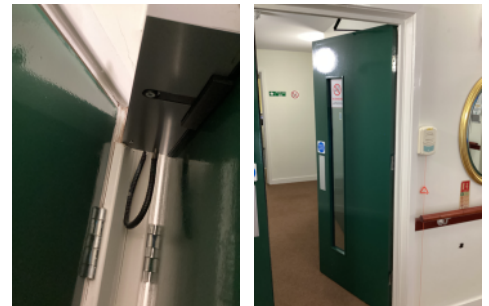
Source Version	6
Category	Escape Routes & Fire Spread
Sub Category	Fire Doors
Action Required	Repair the self-closing device on the following doors: second floor double doors leading to risers
Priority	High
Status	Identified
Owner	Customer Homes
Due Date	20 December 2022

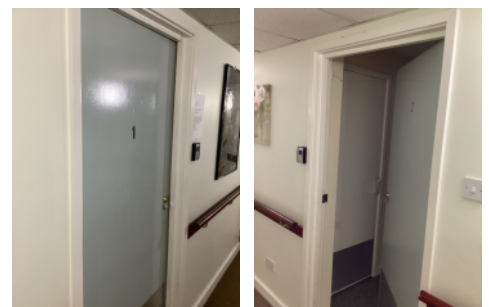
Source Version	6
Category	Escape Routes & Fire Spread
Sub Category	Fire Doors
Action Required	self-closers are not provided on the following doors: flat 1 and 2.
Priority	High
Status	Identified
Owner	Customer Homes
Due Date	20 December 2022
