Fire Risk Assessment

1-26, 50 Well Street

Version 5

5 October 2023

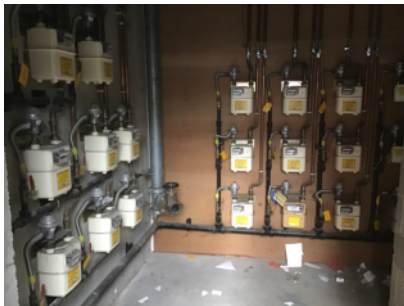
Gas meters located in externally accessed ventilated room.

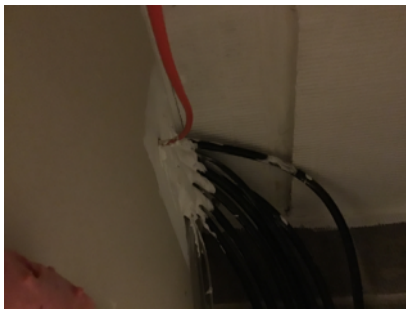
Example of fire stopping within riser cupboards

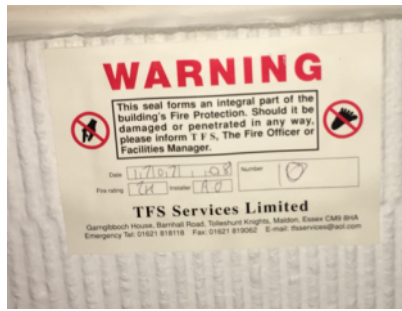
Example of fire stopping label within riser cupboards.

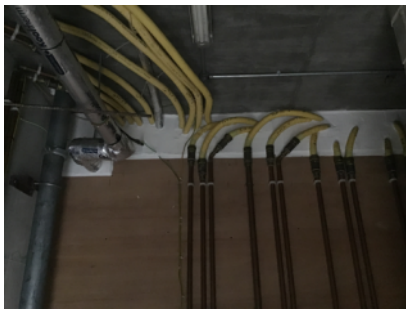
Fire stopping within gas meter cupboard

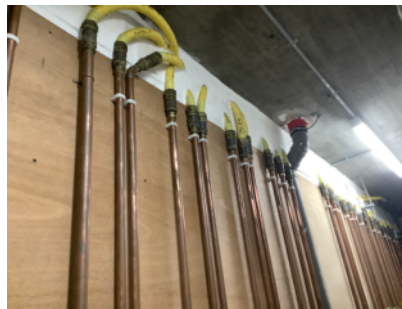
Fire stopping within gas meter room

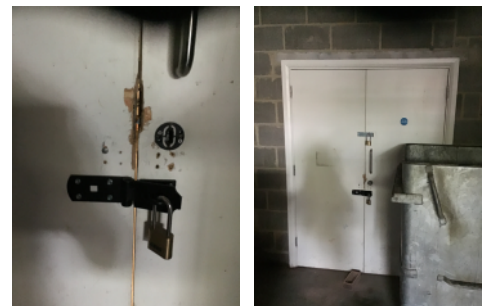
Task 2

Source Version 2
Category Escape Routes & Fire Spread
Sub Category Fire Doors
Action Required This door, located within the bin store could not be accessed. However, the door is so severely damaged it is possible to see through to the room on the other side which appears to house the electrical mains intake and distribution. This door should be repaired (or replaced if necessary) to FD30S standard of fire resistance, be kept locked shut, with the appropriate “Fire Door Keep Locked” signage fitted.

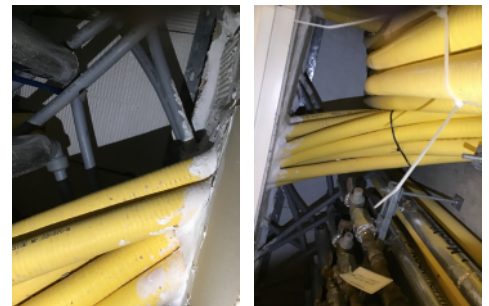
Task 4

Source Version	2
Category	Fire Prevention
Sub Category	Gas
Action Required	It appears fire stopping has been installed through the vertical levels of the gas riser. This may compromise the required ventilation for this riser. It is advised advice is sought from the appropriate gas supply body to ensure that this complies and does not contradict with ventilation requirements. 05/10/2023 There is no evidence that advise has been sought so this task remains outstanding.
Priority	Advisory
Status	Identified
Owner	Customer Homes
Due Date	7 October 2022

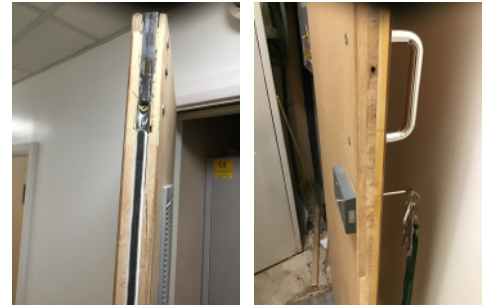
Task 5

The left leaf of the double doors to the lift motor room are damaged to a degree that its fire resistance has been compromised. The right hand leaf has been adjusted (planed) to a degree that is probably beyond the limit of the manufacturers recommendations, as it has exposed the doors core (there is no hardwood lip). This door set should be replaced to ensure it affords the required FD30S standard of fire resistance.

Source Version 2
Category Escape Routes & Fire Spread
Sub Category Fire Doors
Action Required Replace the following doors with FD30S doors:

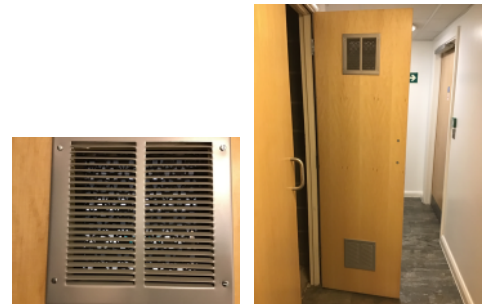
Task 6

Source Version 1
Category Escape Routes & Fire Spread
Sub Category Construction and Glazing
Action Required Ventilation grills installed within fire resisting doors fitted to riser cupboards appear to be intumescent. This should be confirmed to ensure the fire resisting integrity of these doors.

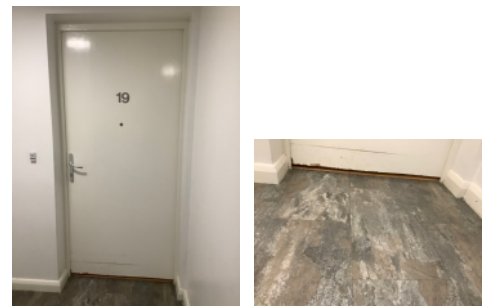
Task 8

Source Version	4
Category	Escape Routes & Fire Spread
Sub Category	Fire Doors
Action Required	<p>Re-hang the following doors to reduce the threshold gap:</p> <p>FED flat 19</p> <p>05/10/2023 This task is still outstanding.</p>
Priority	Low
Status	Identified
Owner	Customer Homes
Due Date	15 December 2022
