**Fire Risk Assessment**

**1-26 Mildmay Avenue**

Version 6

29 January 2024

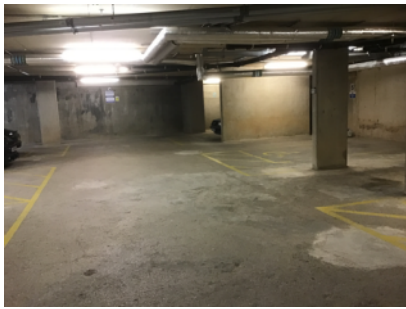
Basement carpark

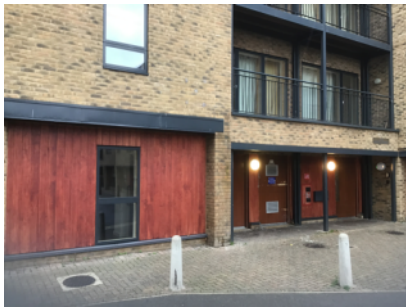
Ground floor partially timber clad

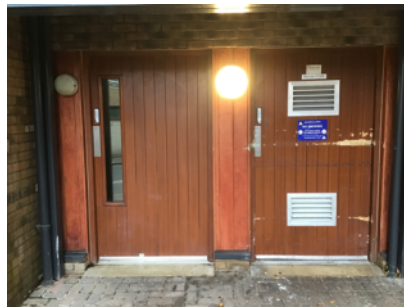
Access to basement carpark (left), and refuse store (right)

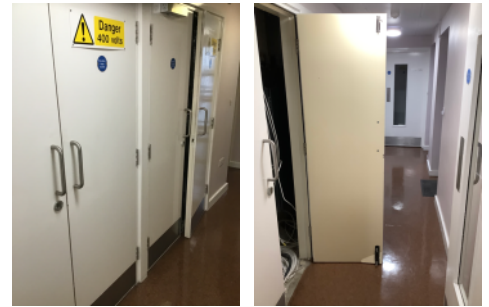
Source Version	1
Category	Escape Routes & Fire Spread
Sub Category	Fire Doors
Action Required	Replace the locks, in the following doors:  Electrical riser cupboard door (both doors) ground floor  Electrical riser cupboard door (both doors), 2nd floor.  Electrical riser cupboard door (right hand), 4th floor.  NB: these doors are provided with self closing devices and therefore this task has been afforded a lower priority.  Version 4 - 17/11/21 This task is still outstanding.  31/08/23 This task is still outstanding.
Priority	Low
Status	Identified
Owner	Neighbourhood Services
Due Date	13 January 2021

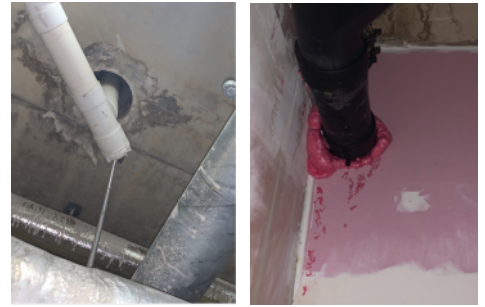
Source Version	2
Category	Escape Routes & Fire Spread
Sub Category	Construction and Glazing
Action Required	<p>There are numerous penetrations through the concrete slab ceiling in the basement carpark and associated plant rooms/intake rooms which require fire stopping.</p> <p>Some penetrations have been sealed, however incorrect fire stopping ,ethics and materials have been used.</p> <p>It is recommended to conduct a full fire stopping survey in this area to ensure there is adequate fire separation between the basement carpark and the flats above.</p> <p>31/08/23 This task is still outstanding.</p>
Priority	High
Status	Identified
Owner	Customer Homes
Due Date	16 March 2021

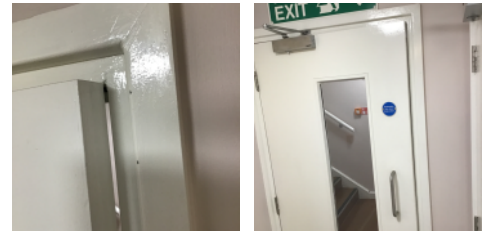
Source Version	4
Category	Escape Routes & Fire Spread
Sub Category	Fire Doors
Action Required	Re-hang the following doors to enable the doors to easily close:  The ground floor corridor door protecting the staircase from the electrical cupboards and flats 1,2,3 is not closing fully.  All corridor doors on the first and second floors should be checked as most do not close fully into their frames.  The lobby door to the cycle store is also not closing fully.  31/08/23 This task is still outstanding.
Priority	High
Status	Identified
Owner	Customer Homes
Due Date	15 February 2022
