Fire Risk Assessment

1-29 Kinver House

Version 6

2 October 2023

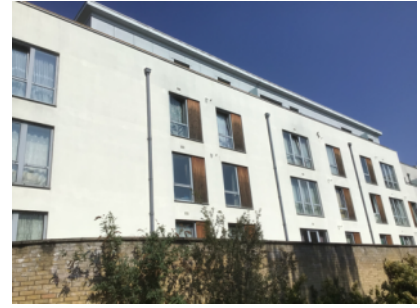
Rendered external wall surface

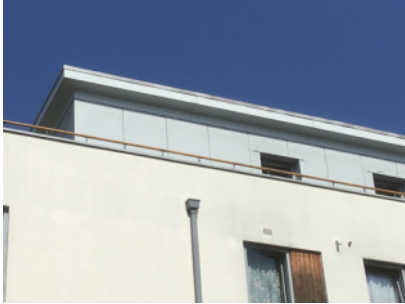
External walls – rear elevation

Cladded external wall system installed on fourth floor.

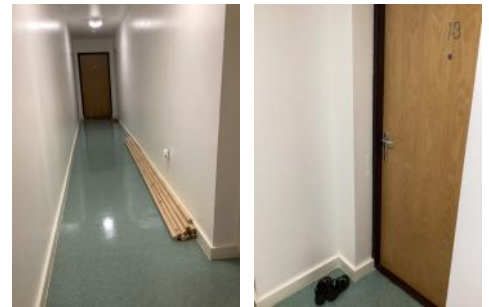
Although the amount of items currently in escape routes is not unreasonable, routes should be monitored to ensure that a build-up of items does not impede escape. This should include the removal of the electric mobility buggy on the ground floor within escape route and stairwell.

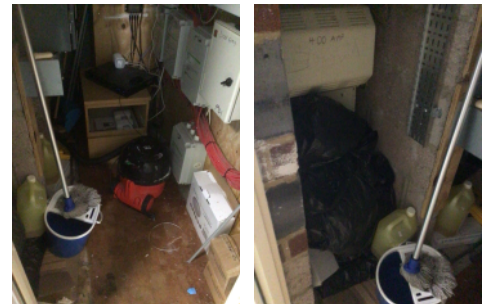
Task 6

The electrical cupboard on the ground floor is currently being used to store cleaners equipment and chemicals. This should be removed.
