**Fire Risk Assessment**

**1-36 Repton House**

Version 7

7 August 2023

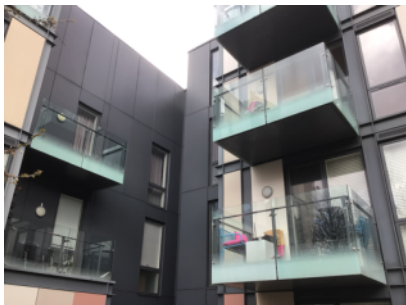
External walls with balconies rear elevation

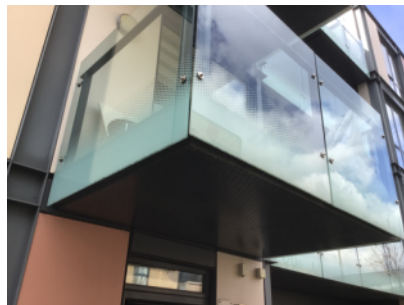
Construction of private balconies

Glazed up-stands with metal decks.

Whilst beyond the scope of the Fire Safety Order, as a private balcony is not part of the common area, residents should be advised about the risks arising from the presence of combustible materials on balconies. They should make clear that smoking, the use of barbecues and storage of flammable property on balconies can increase that risk. Advice from fire and rescue authorities is also clear that barbecues should not be used on balconies. (MHCLG Advice Note on Balconies on Residential Buildings, 2019)

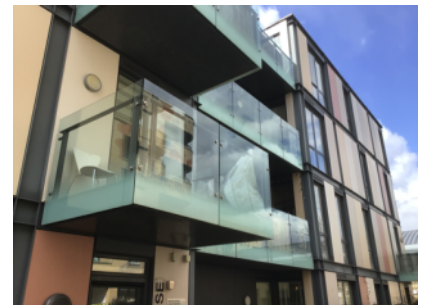
External walls - front elevation

The external walls are clad in some form of composite cladding material. This may be a High Pressure Laminate material although this cannot be confirmed within the scope of this inspection.

Formal confirmation of the composition of this material should be sought.

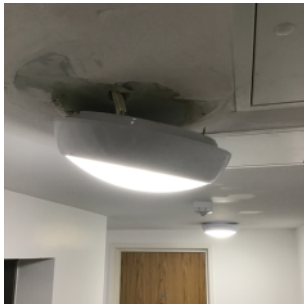
There is a damaged light fitting on the first floor ceiling.

Damaged light fitting on the first floor

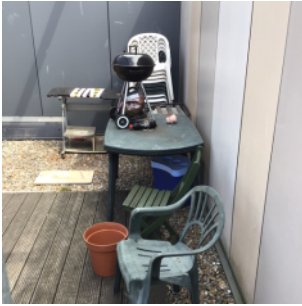
Cooking does not take place in the common areas but there is a barbecue on the roof top decked area.

Barbecue on roof

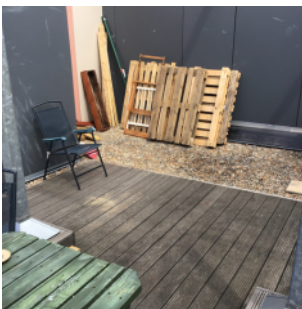
There is an amount of combustible waste and a barbecue in the timber decked roof top garden which should be removed.

Combustible storage on roof top garden.

Residents should be reminded of the risks posed by using barbecues on timber decking.

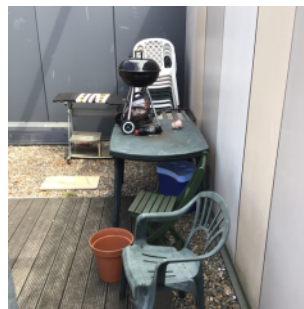
Barbecue and lighting fluid in roof top garden

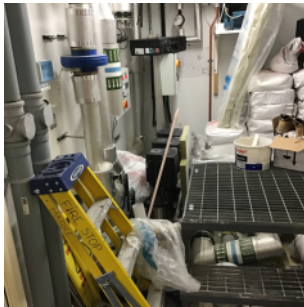
Ground floor plant room being used as a store

Once the fire stopping and decorating work is complete all plant rooms and riser cupboards should be cleared of storage.

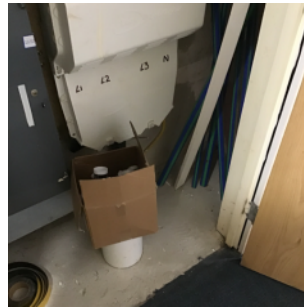
Combustible materials in riser cupboards

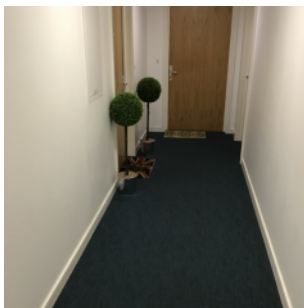
Reasonable items in escape route as long as they are kept to one side.

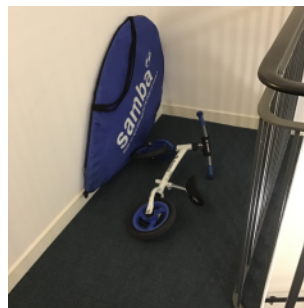
Items should not be stored in the staircase

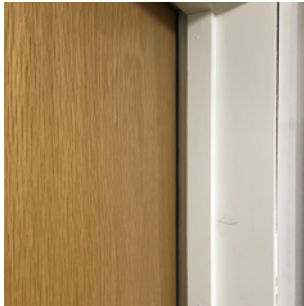
The staircase door, opposite flat 13, does not completely close on the action of the self closing device.

Ground floor corridor door not closing fully

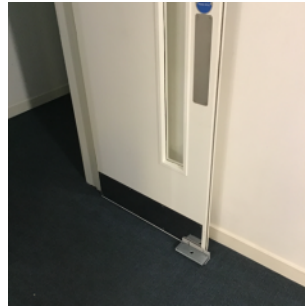
First floor staircase door wedged open

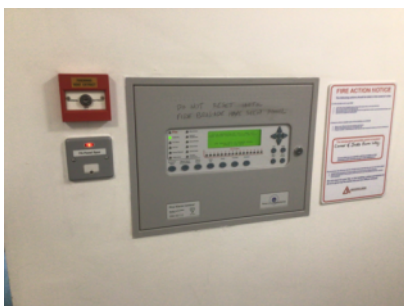
Panel condition at time of inspection.

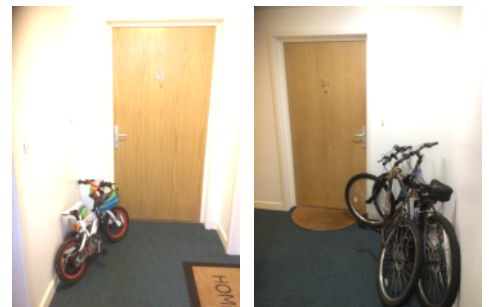
Source Version	5
Category	Escape Routes & Fire Spread
Sub Category	Ease of Use
Action Required	Bikes should not be stored as to obstruct escape routes.
