Fire Risk Assessment

1-8 Stables Lodge

Version 4

22 August 2023

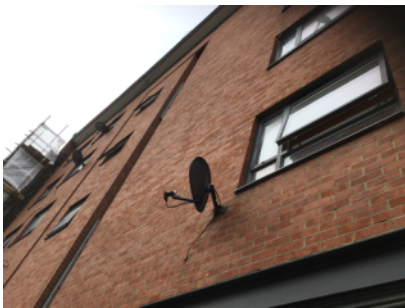
Brick walls to front face of building

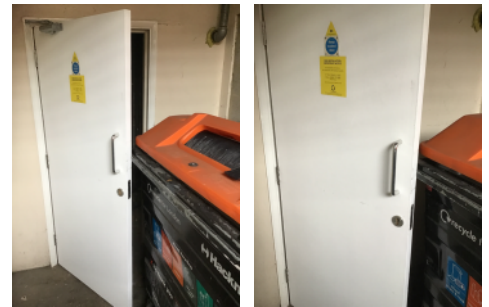
Task 8

The positioning of the bins in the bin store means that the door to the gas meter cupboard remains open. This was identified in the previous FRA.

A barrier or rail should be installed to ensure this door remains closed and locked shut. The location of the gas meter cupboard within the bin store creates a high risk of fire spread to the gas installations, should a fire occur in the bin store.

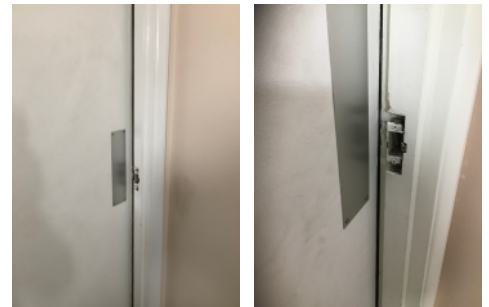
The door from the entrance hallway, ground floor, through to the bin store (and electrical and gas cupboard) is damaged and requires replacing.

VERSION 3: The door leaf has been replaced, however it does not fit within the frame and therefore does not close. This door should therefore be adjusted to ensure it fully closes on the action of the self-closing device.

Replace the following doors with FD30S self-closing doors:

Also the frame requires repair, including the removal of the now redundant lock strike-plate and keep.

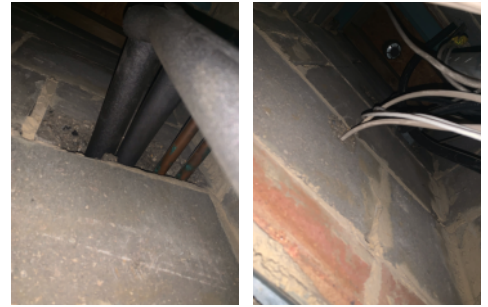
There are numerous pipe and cable penetrations within riser cupboards on all floors which are not fire stopped. These require fire stopping to ensure adequate compartmentation is provided between risers and the common parts.

Provide fire stopping around pipe and cable penetrations in the following locations:

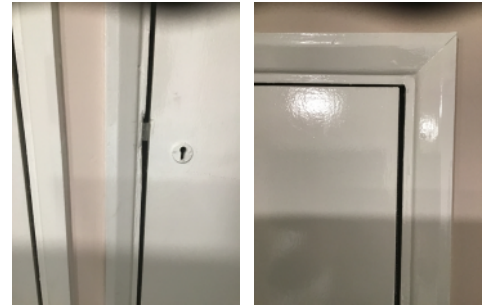
Task 17

There are excessive gaps on all riser cupboard doors, in some cases as much as 13mm. This exceeds the maximum gap permitted for fire doors (3mm +/- 1mm). These doors should be adjusted to reduce these gaps.

Re-hang the following doors to reduce the gaps around the doors:
