**Fire Risk Assessment**

**14 Graham Street**

Version 4

29 August 2023

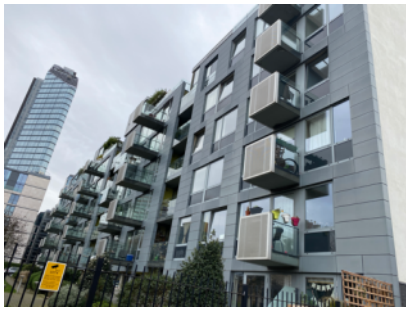
Unidentified (metallic) EWS - rear of building

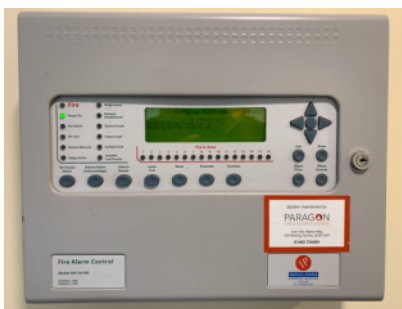
Panel for smoke detection for AOV actuation

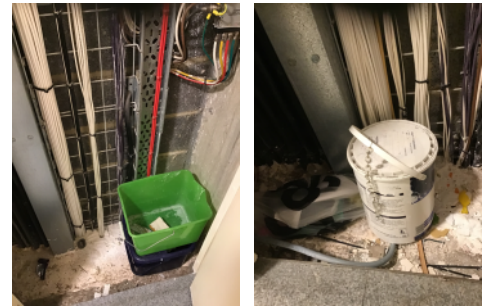
Source Version	1
Category	Fire Prevention
Sub Category	Housekeeping
Action Required	Combustibles should not be stored or found within electrical cupboards
Priority	Medium
Status	Identified
Owner	Neighbourhood Services
Due Date	9 February 2021
