**Fire Risk Assessment**

**183 Richmond Road**

Version 6

15 August 2023

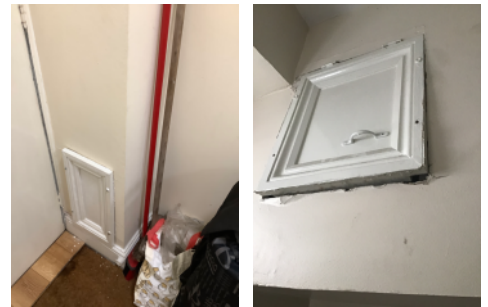
There is some pipework which has been enclosed along the common entrance hallway. There are several breaches in the integrity of this enclosure. It is apparent that this pipework enters at least one of the flats. This pipework should be properly fire stopped where it penetrates into flats, or this enclosure repaired to ensure it provides at least 30 minutes fire resistance between flats, and between flats common parts.

VERSION 2: The remedial work recommended within the previous FRA for this issue has not been completed, and therefore this task remains as “identified” within this FRA.

Some remedial work has been carried out but this task is still outstanding.
