Fire Risk Assessment

220-222 A-H Queensbridge Road

Version 3

15 August 2023

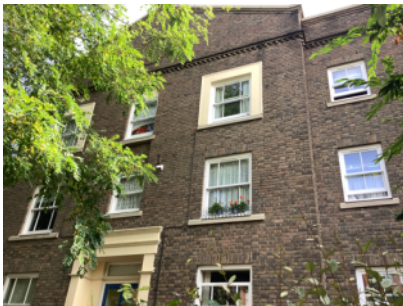
External walls - front elevation

Brick external walls with no external wall systems installed.

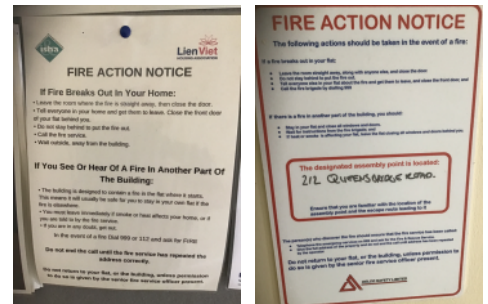
Task 6

The presence of a common fire alarm suggests a simultaneous evacuation policy is in place. However the Fire Action Notice provided is that for a stay put policy which may cause confusion to residents in the event of a fire or fire alarm actuation.

Source Version	1
Category	Signs & Notices
Sub Category	Other Signage
Action Required	The current fire action notices are not suitable for a simultaneous evacuation strategy, which is what the presence of a common fire alarm suggests. The notices should be replaced with ones which reflect the building's fire safety measures and explain the evacuation strategy in place. A simultaneous evacuation policy contradicts national guidance for a building of this type. Please see comments in the Detection and Warning section of this report. VERSION 2: This task, recommended in the previous FRA, has not been completed and therefore remains as an identified task within this version of the buildings fire risk assessment.
Priority	Medium
Status	Identified
Owner	Neighbourhood Services
Due Date	26 January 2021

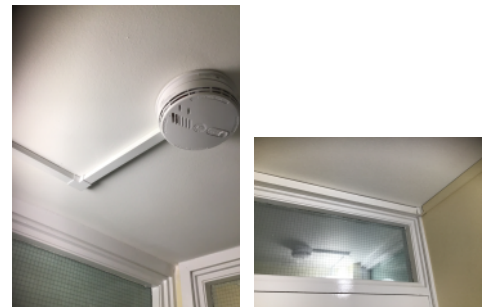
Task 8

Some wiring within common parts are suspended in uPVC conduit. A requirement introduced in 2015 in BS 7671 which covers electrical installations in the UK, states that all new wiring systems to use metal, rather than plastic, to support cables in escape routes, to prevent their premature collapse in the event of a fire.

Source Version	1
Category	Escape Routes & Fire Spread
Sub Category	Ease of Use
Action Required	Some wiring within common parts are suspended in uPVC conduit. A requirement introduced in 2015 in BS 7671 which covers electrical installations in the UK, states that all new wiring systems to use metal, rather than plastic, to support cables in escape routes, to prevent their premature collapse in the event of a fire.
Priority	Advisory
Status	Identified
Owner	Customer Homes
Due Date	28 July 2022

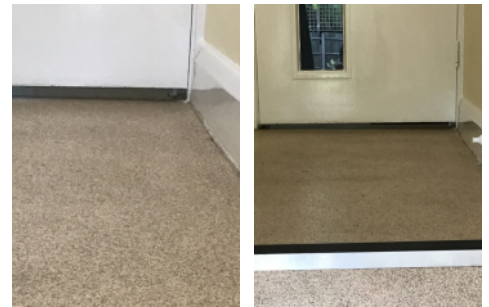
Task 9

The threshold gap on all Lobby doors is above an acceptable limit. The lobby doors on the 1st and 2nd floors have a threshold behind the door which mitigates the risk of the passage of smoke to some extent and therefore is of a lower priority. However, the ground floor lobby door does not and this is of a higher priority.

Source Version	1
Category	Escape Routes & Fire Spread
Sub Category	Fire Doors
Action Required	Re-hang the following doors to reduce the gaps around the doors: The threshold gap on all Lobby doors. The doors on the 1st and 2nd floors have a threshold below the door which mitigates the risk of the passage of smoke to some extent and therefore is of a lower priority. However, the ground floor lobby door does not and this is of a higher priority. VERSION 2: This task, recommended in the previous FRA, has not been completed and therefore remains as an identified task within this version of the buildings fire risk assessment.
Priority	Medium
Status	Identified
Owner	Customer Homes
Due Date	26 January 2021
