Fire Risk Assessment

25-28 Canonbury Court

Version 4

29 August 2023

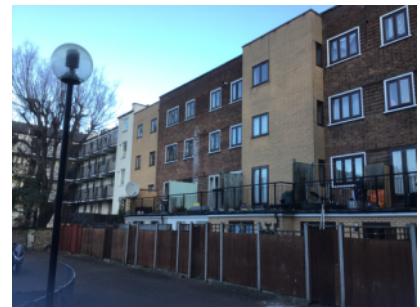
Rear elevation- brick/mortar walls, private balcony on 1st floor.

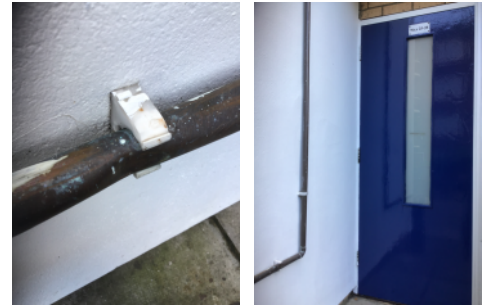
Action Required A gas pipe serving a flat on the second floor, is located immediately outside of the main entrance door. This pipe is located where the main entrance door opens and the action of the door is causing serious damage to this pipe. This pipe should be re-routed or protection provided to prevent damage to the extent it is at risk of failure.

VERSION 3: This task has not been completed, and therefore remains as an identified task within this version of the FRA. The date that the original task was generated remains unchanged.
