**Fire Risk Assessment**

**27-45 Mildmay Avenue**

Version 6

29 January 2024

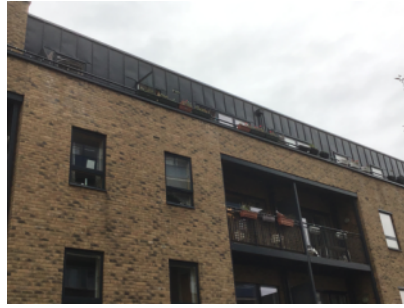
Metallic cladded external wall system on fourth (uppermost) floor.

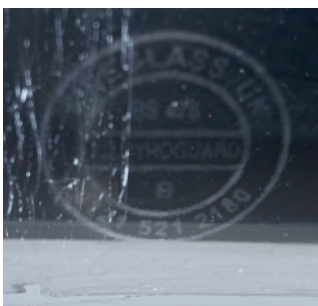
“Pyroguard” FR Glazing in corridor doors.

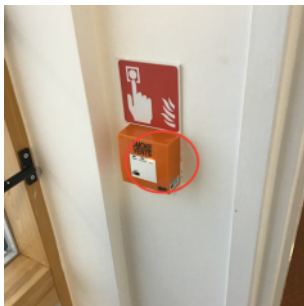
Smoke vent showing a fault light on the 2nd floor.

Fault light on smoke vent actuator
