**Fire Risk Assessment**

**3-32, 857 Lea Bridge Road**

Version 4

13 September 2023

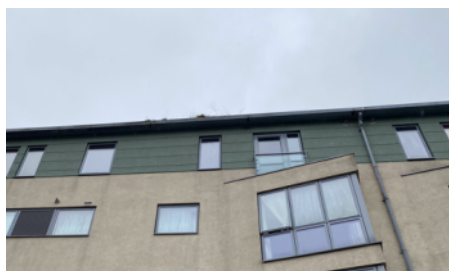
Unidentified external wall system installed on the fourth floor.

Assessment of the fire risks of external walls and any cladding are excluded from the scope of this current fire risk assessment, as this is outside our expertise. (6) Accordingly, it is strongly recommended that you obtain advice from qualified and competent specialists on the nature of, and fire risks associated with, the external wall construction, including any cladding, of this building.

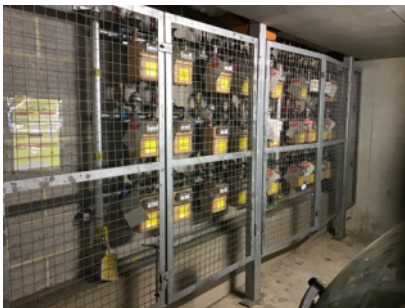
Gas meters located within the undercroft carpark

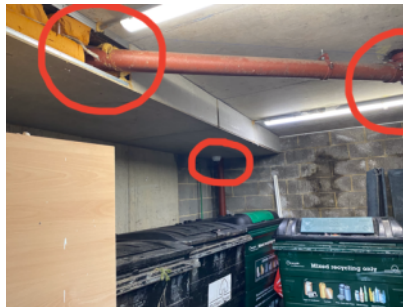
Large pipe penetrations without fire stopping within the bin store.

2	Escape Routes & Fire Spread	Construction and Glazing	<p>Provide fire stopping around pipe penetrations in the following locations:</p> <p>Within the bin store, which is located externally. Although the bin store is located externally it appears these penetrations through the concrete slab and into the flats above.</p> <p>VERSION 3: The remedial work, recommended in previous FRAs has not been completed, and therefore remains “identified” within this version of the FRA.</p> <p>13/09/2023 This task is still outstanding.</p>	High	Identified
---	-----------------------------	--------------------------	---	------	------------

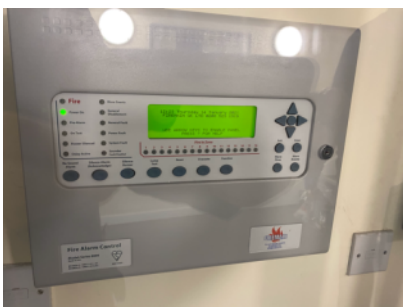
The fire alarm panel.

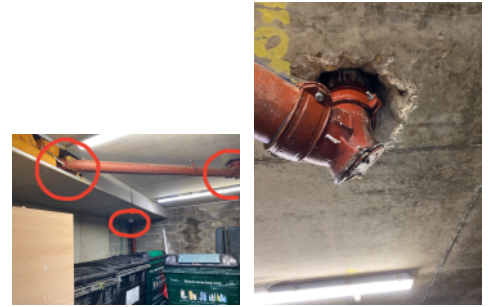
VERSION 3: The remedial work, recommended in previous FRAs has not been completed, and therefore remains “identified” within this version of the FRA.

13/09/2023  
This task is still outstanding.

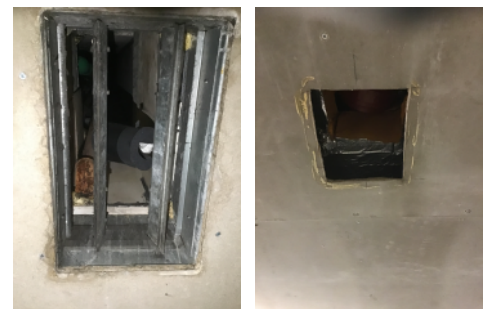
Source Version	1
Category	Escape Routes & Fire Spread
Sub Category	Construction and Glazing
Action Required	Within the undercroft carpark, there are breaches of the fire resisting ceiling which have no fire stopping, or, are covered with grilles and inspection plates which are not fire resisting. It is imperative that the integrity of the concrete slab between the carpark and the flats above is maintained to ensure that any vehicle fire is not able to affect the flats above.
	VERSION 3: The remedial work, recommended in previous FRAs has not been completed, and therefore remains “identified” within this version of the FRA.
	13/09/2023 This task is still outstanding.
Priority	High
Status	Identified
Owner	Customer Homes
Due Date	16 May 2020

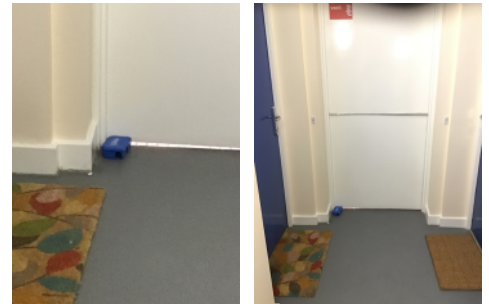
Source Version	1
Category	Escape Routes & Fire Spread
Sub Category	Fire Doors
Action Required	Repair the following doors to an FD30S standard:  The smoke shaft doors adjacent to flats 20, 28 and 32 have an excessive gap at the threshold. These should be repaired or replaced.  VERSION 3: The remedial work, recommended in previous FRAs has not been completed, and therefore remains “identified” within this version of the FRA.  13/09/2023 This task is still outstanding.
Priority	High
Status	Identified
Owner	Customer Homes
Due Date	16 May 2020

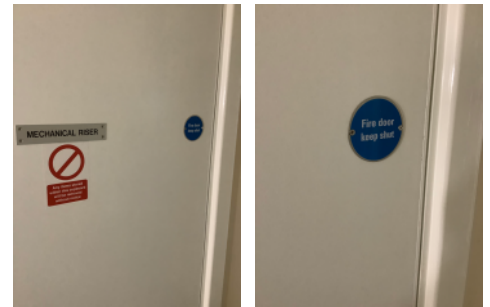
Source Version	3
Category	Signs & Notices
Sub Category	Fire Door Signage
Action Required	Replace Fire Door Keep Shut signs with Fire Door Keep Locked signs on the following doors:  Riser and service cupboard doors  13/09/2023 This task is still outstanding.
Priority	Low
Status	Identified
Owner	Neighbourhood Services
Due Date	19 October 2022

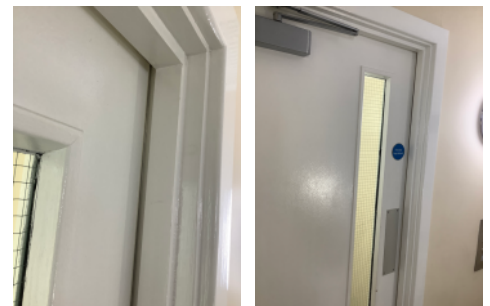
Source Version	3
Category	Escape Routes & Fire Spread
Sub Category	Fire Doors
Action Required	Re-hang the following doors to enable the doors to easily close:  Staircase door, to flats 17-24. The position of the magnetic lock system seems to prevent the door from fully closing on the action of the self closing device.  13/09/2023 This task is still outstanding.
Priority	High
Status	Identified
Owner	Customer Homes
Due Date	17 January 2022
