Fire Risk Assessment

30 Shore Road

Version 5

5 October 2023

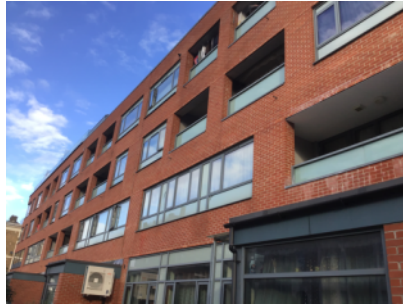
External walls- Brick/mortar construction - side elevation

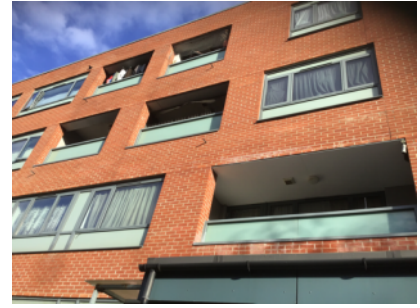
Brick/mortar construction with glazed panels front elevation

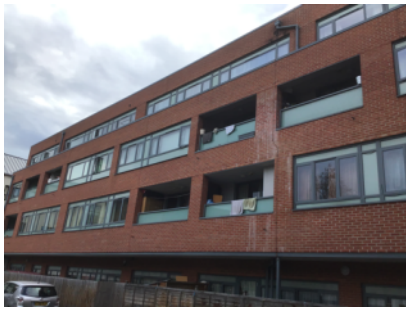
Recessed balconies at front of building.

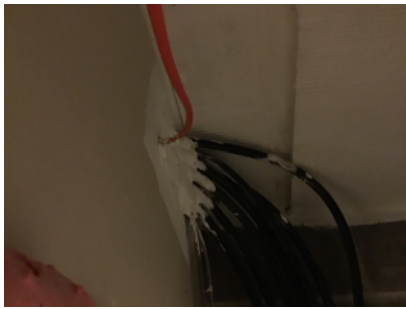
Example of fire stopping within riser cupboards

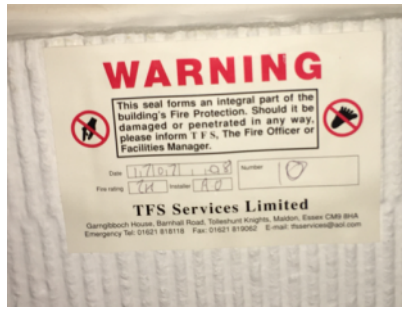
Example of fire stopping label within riser cupboards.

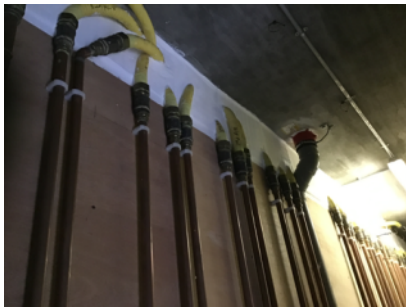
A good standard of fire stopping within the gas meter room.

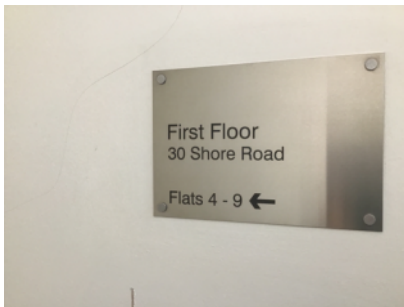
Floor numbers are clearly identified

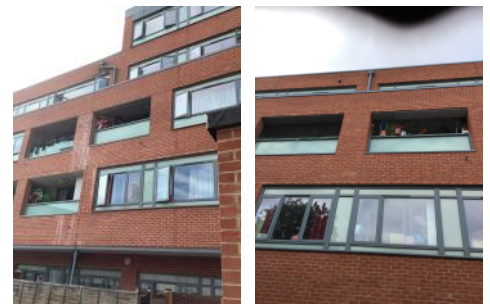
Task 2

Source Version	2
Category	Fire Prevention
Sub Category	Housekeeping
Action Required	There are some combustibile items located on private balconies. Whilst beyond the scope of the Fire Safety Order, as a private balcony is not part of the common area, residents should be advised about the risks arising from the presence of combustibile materials on balconies. They should make clear that smoking, the use of barbecues and storage of flammable property on balconies can increase that risk. Advice from fire and rescue authorities is also clear that barbecues should not be used on balconies. (MHCLG Advice Note on Balconies on Residential Buildings, 2019)
Priority	Advisory
Status	Identified
Owner	Neighbourhood Services
Due Date	7 October 2022

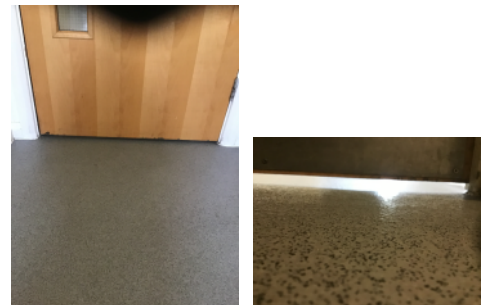
Task 4

Source Version	2
Category	Escape Routes & Fire Spread
Sub Category	Fire Doors
Action Required	Re-hang the following doors to reduce the gaps around the doors: The threshold gaps on all staircase doors and cross corridor doors are excessive and should be reduced.
	05/10/2023 This task is still outstanding.
Priority	Low
Status	Identified
Owner	Customer Homes
Due Date	7 October 2021

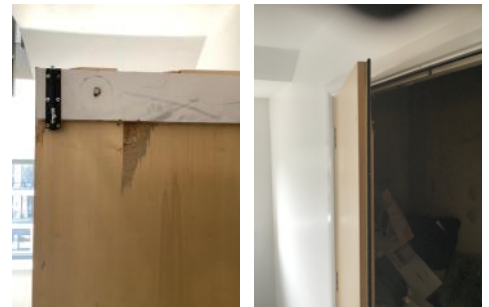
Task 5

Source Version	2
Category	Escape Routes & Fire Spread
Sub Category	Fire Doors
Action Required	Replace the damaged door to FD30S standard: The door to the riser cupboard housing the dry riser on the second floor is damaged and should be replaced. VERSION 3: The remedial work recommended in the previous FRA has not been completed. 05/10/2023 An attempt has been made to repair this door but not to the correct standard so this task is still outstanding.
Priority	Medium
Status	Identified
Owner	Customer Homes
Due Date	7 October 2020

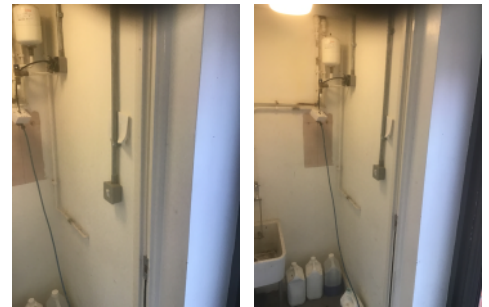
Task 7

Source Version	2
Category	Escape Routes & Fire Spread
Sub Category	Fire Doors
Action Required	The intumescent strips and smoke seals on the following doors are damaged and should be replaced: A section of combined intumescent strip and cold smoke seal on the door to the cleaners cupboard on the ground floor is missing and should be replaced. 05/10/2023 Unable to gain access to this cupboard so this task is still outstanding.
Priority	Low
Status	Identified
Owner	Customer Homes
Due Date	7 October 2021

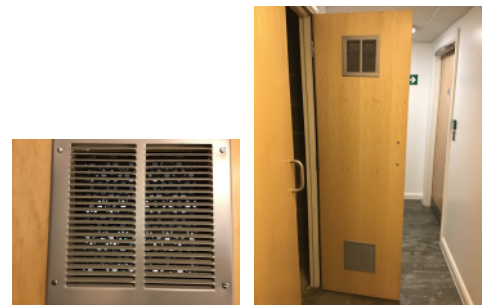
Task 8

Source Version	1
Category	Escape Routes & Fire Spread
Sub Category	Construction and Glazing
Action Required	Ventilation grills installed within fire resisting doors fitted to riser cupboards appear to be intumescent. This should be confirmed to ensure the fire resisting integrity of these doors. 05/10/2023 This task is still outstanding.
Priority	Advisory
Status	Identified
Owner	Customer Homes
Due Date	2 December 2021

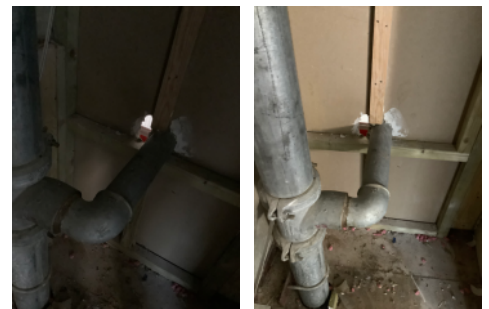
Task 10

Source Version	4
Category	Escape Routes & Fire Spread
Sub Category	Construction and Glazing
Action Required	Provide fire stopping at the following locations: Riser cupboard 2nd floor. 05/10/2023 This task is still outstanding.
Priority	Low
Status	Identified
Owner	Customer Homes
Due Date	15 December 2022
