Fire Risk Assessment

321 Green Lanes

Version 4

31 July 2023

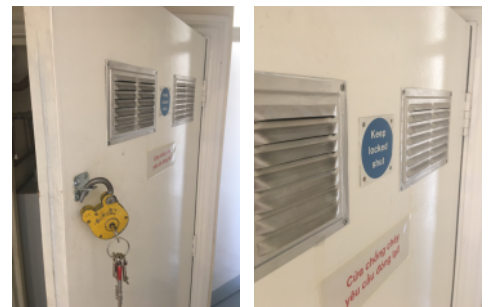
Task 4

There are vent grills installed in the boiler cupboard door. These should be confirmed as being intumescent to maintain the fire resisting integrity requirements of the door.

Source Version	1
Category	Escape Routes & Fire Spread
Sub Category	Fire Doors
Action Required	Ensure ventilation grills in the boiler room door are intumescent. Version 3. 26/9/22 It should be confirmed that these grills are intumescent.
Priority	Medium
Status	Identified
Owner	Customer Homes
Due Date	15 December 2020

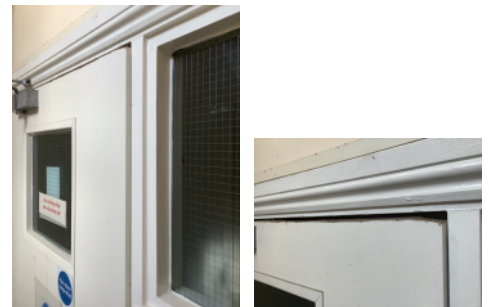
Task 10

Source Version	2
Category	Escape Routes & Fire Spread
Sub Category	Fire Doors
Action Required	Re-hang the first floor lobby door to enable the doors to easily close, and also to reduce the gap at the top of the door. Version 3. 26/9/22 This task is not complete.
Priority	High
Status	Identified
Owner	Customer Homes
Due Date	26 December 2021
