Fire Risk Assessment

37-80 Repton House

Version 7

7 August 2023

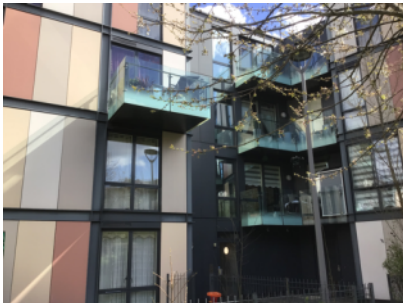
The building has panelled cladding which appears to be a composite boarding material.

External walls and balconies, rear elevation

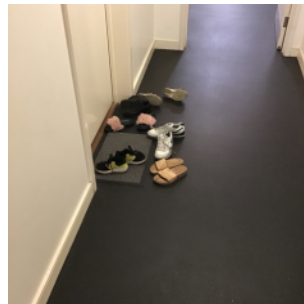
There were a number of items including prams, exercise equipment and storage cabinets located on the common corridors which could impede escape in the event of a fire.

Excessive shoe storage in escape route

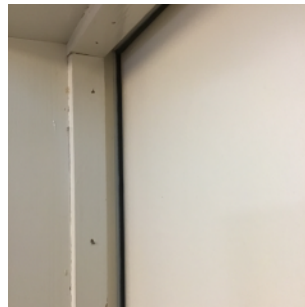
The automatic self closing cross-corridor doors adjacent to flats 60 and 72 require adjusting to ensure they close completely on the action of the self closing device.

Corridor door not closing fully into frame.

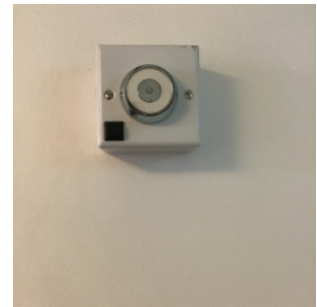
Corridor door not closing fully

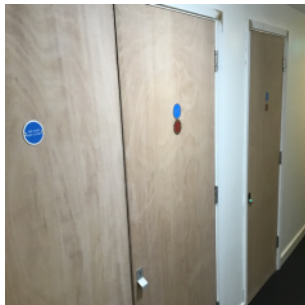
The automatic door hold-open device on the cross-corridor door, adjacent to flat 55 - fails to hold the door open.

Hold open device not working

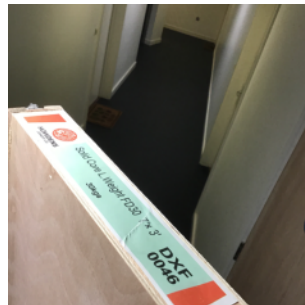
New FD30S fire doors have been fitted on all riser cupboards

New riser cupboard doors

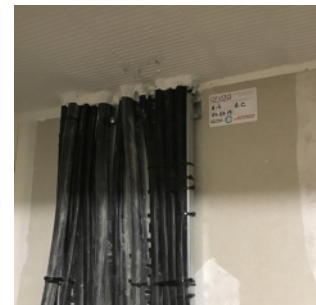
It was noted programme of fire stopping has been undertaken in riser cupboards by "ARVAG" in July 2019.

Evidence of fire stopping

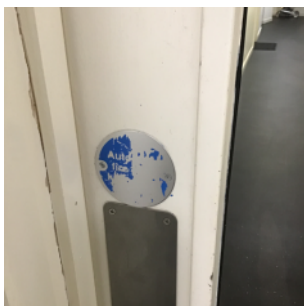
Corridor door next to flat 55

VERSION 3: This task has not been completed.

Fire door signage requires replacing
