Fire Risk Assessment

558 Forest Road, Walthamstow

Version 5

13 September 2023

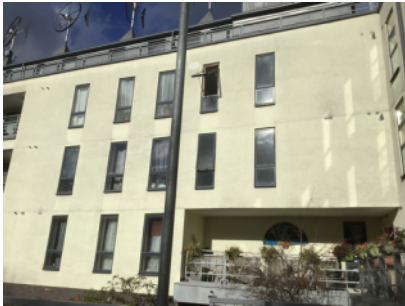
Rendered rear wall.

Rear elevation external wall is rendered, the substrate to which the render has been applied cannot be confirmed within the scope of this FRA.

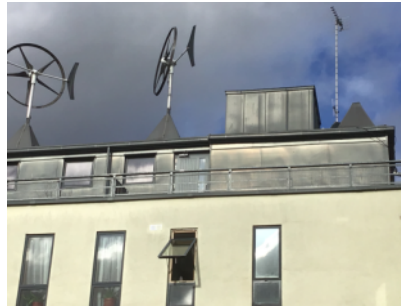
Cladding installed on 4th floor external walls

The top floor (4th floor) has some cladding installed. The cladding type, construction and standard of installation cannot be confirmed within the scope of this FRA.

Assessment of the fire risks of external walls and any cladding are excluded from the scope of this current fire risk assessment, as this is outside our expertise. (6) Accordingly, it is strongly recommended that you obtain advice from qualified and competent specialists on the nature of, and fire risks associated with, the external wall construction, including any cladding, of this building.

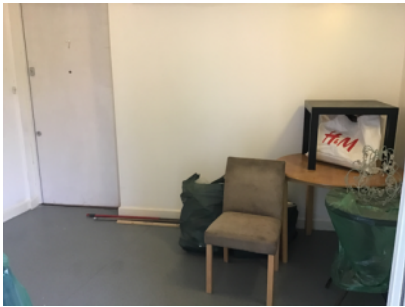
There is an unacceptable amount of combustible items in riser cupboards and in common escape routes.

Combustible storage on second floor outside flat 7

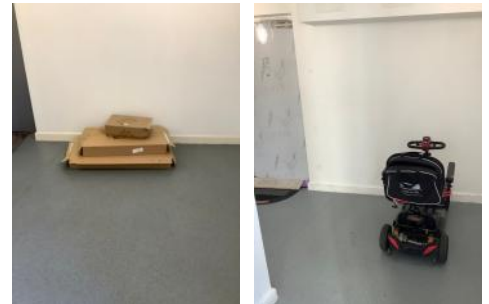
Task 1

Source Version	1
Category	Fire Prevention
Sub Category	Housekeeping
Action Required	The storage of combustible items in communal areas is excessive and should be reduced. Particularly outside flats 7 and 12 VERSION 2: This task has not been completed and combustibles remain in these areas. VERSION 3: This task has not been completed and combustibles remain in these areas. 13/09/2023 This task remains outstanding
Priority	Medium
Status	Identified
Owner	Neighbourhood Services
Due Date	13 March 2019

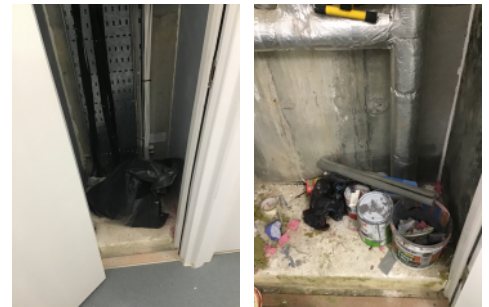
Task 7

Source Version 2
Category Fire Prevention
Sub Category Housekeeping
Action Required The storage of combustible items in riser cupboards should be prohibited.

Risers between 1st and 2nd floors.

Risers between ground and 1st floors.

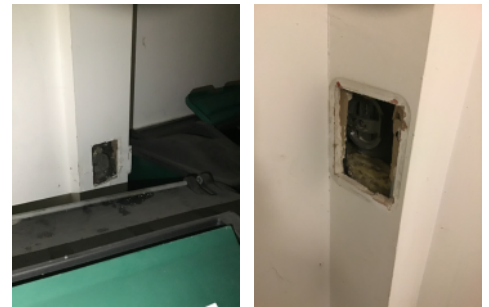
Task 11

Source Version	2
Category	Escape Routes & Fire Spread
Sub Category	Construction and Glazing
Action Required	The walls in the following locations are damaged and should be repaired to achieve the original period of fire resistance: Exposed pipe risers within the bin store, and the bin store lobby.
	VERSION 3: This task is yet to be completed.
	VERSION 4: It was noted that this remedial work, recommended in previous FRAs, has not been completed.
	13/09/2023 This task remains outstanding
Priority	Medium
Status	Identified
Owner	Customer Homes
Due Date	1 January 1971

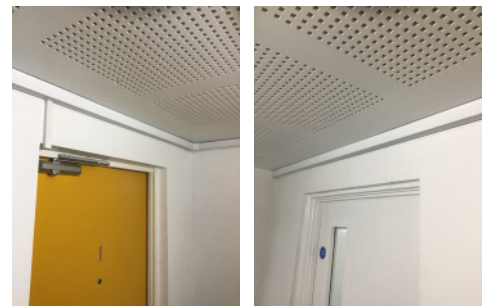
Task 12

Source Version	2
Category	Fire Prevention
Sub Category	Electrical
Action Required	There is electrical wiring suspended within PVCu conduit within common areas and above common fire resisting doors (staircase doors, lobby doors, ground floor). A requirement introduced in 2015 in BS 7671 which covers electrical installations in the UK, states that all new wiring systems to use metal, rather than plastic, to support cables in escape routes, to prevent their premature collapse in the event of a fire. 13/09/2023 This task remains outstanding
Priority	Advisory
Status	Identified
Owner	Customer Homes
Due Date	31 December 1972

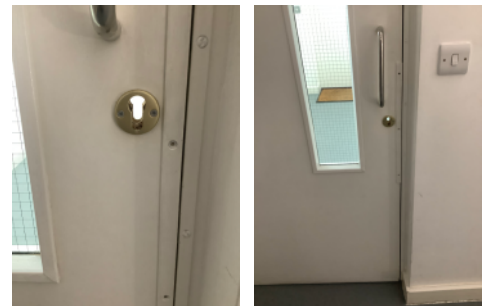
Task 16

Source Version	4
Category	Escape Routes & Fire Spread
Sub Category	Fire Doors
Action Required	Repair the following doors to an FD30S self-closing standard: Lobby door to flats 13 and 14 13/09/2023 This task remains outstanding
Priority	Medium
Status	Identified
Owner	Customer Homes
Due Date	19 April 2022
