Fire Risk Assessment

Adams House

Version 3

5 October 2023

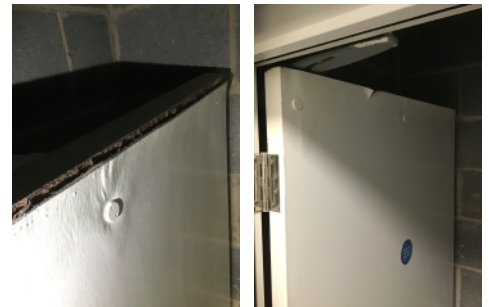
Task 4

VERSION 2: The smoke shaft door on the 2nd floor was found in an open position with a resident reporting that it has been open for some weeks. This door has been severely damaged by water through the open shaft and now will not close. This has left this floor at risk of heat and smoke spread, should a fire occur on another floor and the smoke vent door open on the fire floor. This door should be replaced as soon as possible and the ventilation system tested to ensure it operates correctly. ISHA were contacted immediately via telephone and email to report this urgent issue.

Source Version	2
Category	Escape Routes & Fire Spread
Sub Category	Fire Doors
Action Required	Replace the following doors with FD30S doors: Smoke shaft vent door, 3rd floor adjacent flat 17.
Priority	Critical
Status	Identified
Owner	Customer Homes
Due Date	21 October 2020

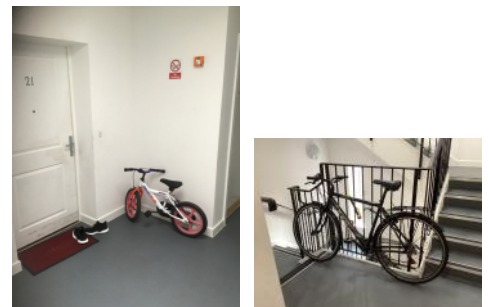
Task 5

Source Version	2
Category	Escape Routes & Fire Spread
Sub Category	Ease of Use
Action Required	Bikes should not be stored as to obstruct escape routes. A bicycle is located on the escape route outside flat 21.
Priority	Low
Status	Identified
Owner	Neighbourhood Services
Due Date	21 October 2021

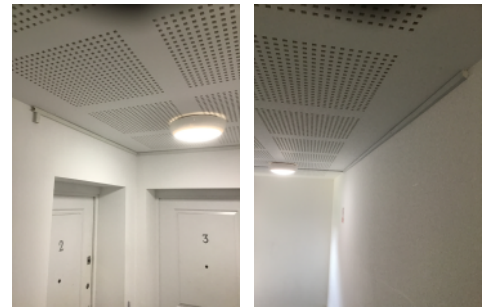
Task 7

There are electrical cables in plastic conduit above flats 2 and 3, also on the ground floor corridor leading to the rear exit. A requirement introduced in 2015 in BS 7671 which covers electrical installations in the UK, states that all new wiring systems to use metal, rather than plastic, to support cables in escape routes, to prevent their premature collapse in the event of a fire. A bicycle is located on the escape route outside flat 21.

Source Version	1
Category	Escape Routes & Fire Spread
Sub Category	Ease of Use
Action Required	There are electrical cables in plastic conduit above flats 2 and 3, also on the ground floor corridor leading to the rear exit. A requirement introduced in 2015 in BS 7671 which covers electrical installations in the UK, states that all new wiring systems to use metal, rather than plastic, to support cables in escape routes, to prevent their premature collapse in the event of a fire.
Priority	Low
Status	Identified
Owner	Customer Homes
Due Date	2 October 2021

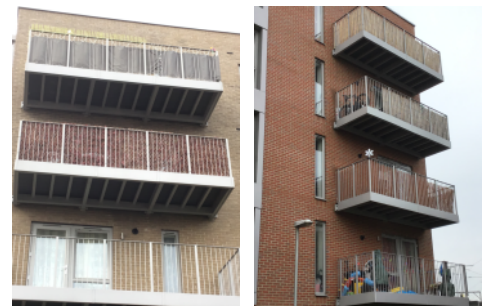
Task 8

Source Version	1
Category	Fire Prevention
Sub Category	Housekeeping
Action Required	<p>There were combustible items evident on residents private balconies, including a solid fuel BBQ.</p> <p>Also, the base of each balcony is constructed of timber decking.</p> <p>Whilst beyond the scope of the Fire Safety Order, as a private balcony is not part of the common area, residents should be advised about the risks arising from the presence of combustible materials on balconies. They should make clear that smoking, the use of barbecues and storage of flammable property on balconies can increase that risk. Advice from fire and rescue authorities is also clear that barbecues should not be used on balconies.</p>
Priority	Advisory
Status	Identified
Owner	Neighbourhood Services
Due Date	2 October 2022

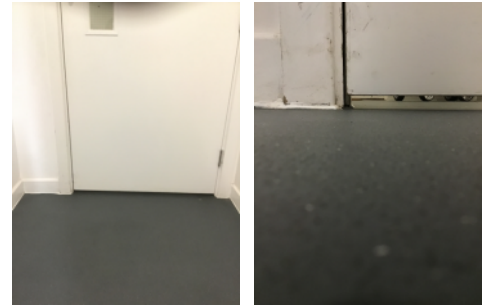
Task 11

The threshold gap on the staircase doors on the third floor are excessive and should be reduced.

Source Version	1
Category	Escape Routes & Fire Spread
Sub Category	Fire Doors
Action Required	Re-hang the following doors to reduce the gaps around the doors: The threshold gap on the staircase doors on the second and third floor are excessive and should be reduced.
Priority	Low
Status	Identified
Owner	Customer Homes
Due Date	2 October 2021

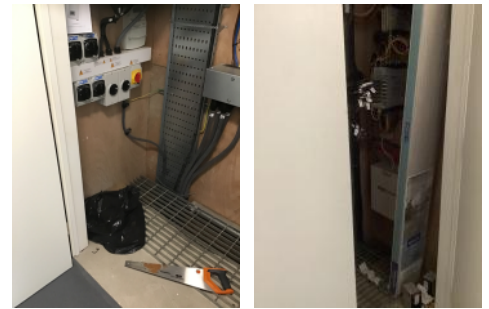
Task 12

Source Version	1
Category	Fire Prevention
Sub Category	Housekeeping
Action Required	The storage of combustible items in riser cupboards should be prohibited.
Priority	Medium
Status	Identified
Owner	Neighbourhood Services
Due Date	2 October 2020
