Fire Risk Assessment

Barnes House

Version 4

2 October 2023

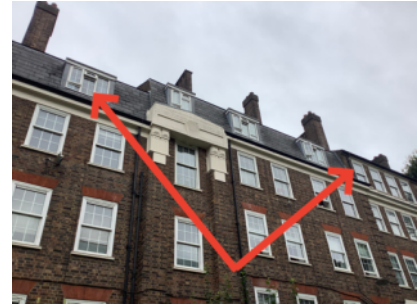
Vertically hung tiles, top floor

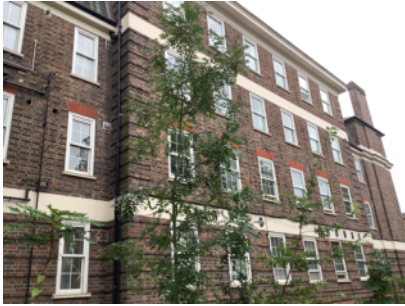
Brick/mortar external walls, end elevation.

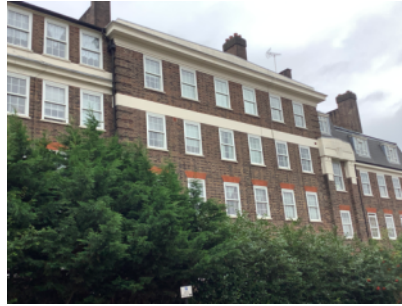
Brick/mortar external walls, rear elevation.

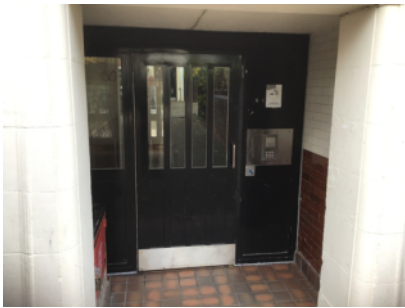
The main entrance doors are of a robust design and are in good condition and would take considerable effort to effect a forced entry by the attending fire service. It is therefore advisable to provide a Fire Service override control to the main entrance doors due to the size and layout of this building.

Robust construction of main entrance door.

Source Version	1
Category	Fire Fighting
Sub Category	Fire Service Access & Facilities
Action Required	Provide a Fire Service override control to the main entrance doors.
Priority	Low
Status	Identified
Owner	Customer Homes
Due Date	1 September 2021

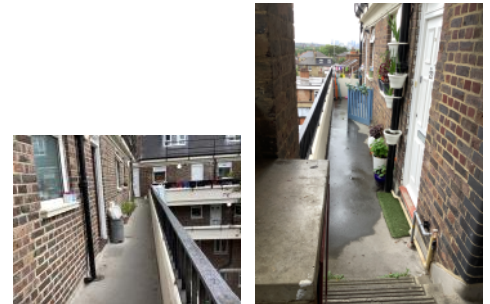
Task 1

Source Version	1
Category	Escape Routes & Fire Spread
Sub Category	Ease of Use
Action Required	Obstructions should be removed from the escape routes in the following locations: All landings were observed to have items present which may present an obstruction for escaping persons in the event of a fire. Residents should be reminded of the importance of keeping escape routes clear. VERSION 2: This task has not been completed and all landings have an unacceptable level of obstructions present. VERSION 3: Numerous items were present on common escape routes at the time of his inspection.
Priority	Medium
Status	Identified
Owner	Neighbourhood Services
Due Date	1 September 2020

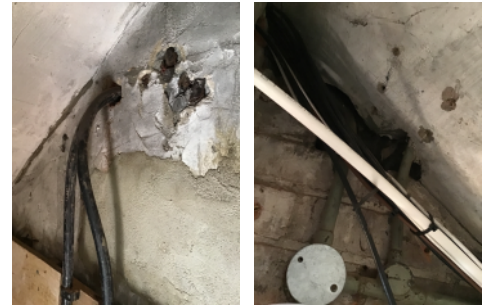
Task 7

Source Version	1
Category	Escape Routes & Fire Spread
Sub Category	Construction and Glazing
Action Required	Provide fire stopping around cable penetrations in the following locations: Electrical cupboard, ground floor. (Staircase between flats 1 and 3)
Priority	High
Status	Identified
Owner	Customer Homes
Due Date	1 December 2019
