Fire Risk Assessment

Delta House

Version 3

31 August 2023

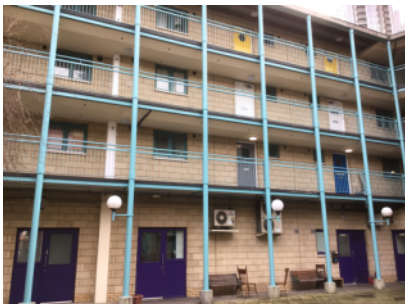
External walls (courtyard side) of the building

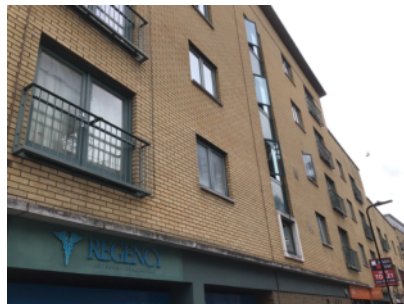
External walls (outside) of the building

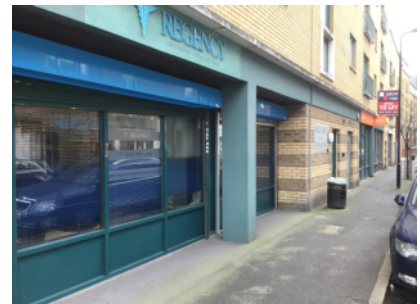
Commercial units occupy the ground floor of the building.

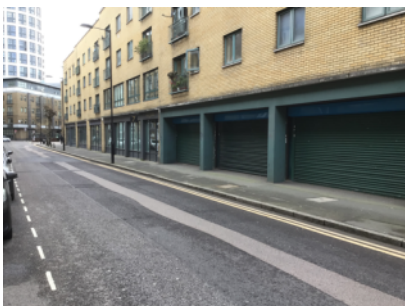
Commercial units occupy the ground floor of the building.

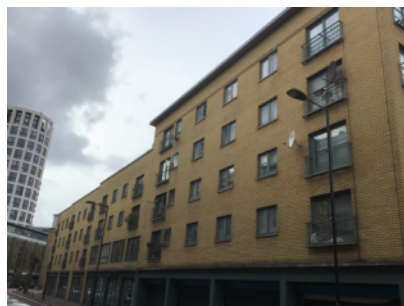
External walls (outside) of the building

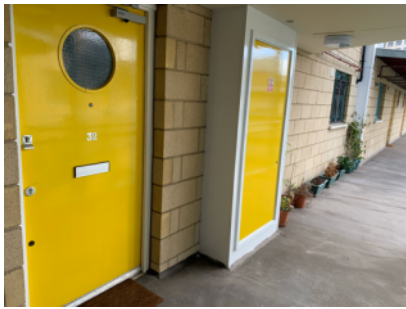
Showing glazed fanlights in doors and glazed flat windows (all above 1.1m)

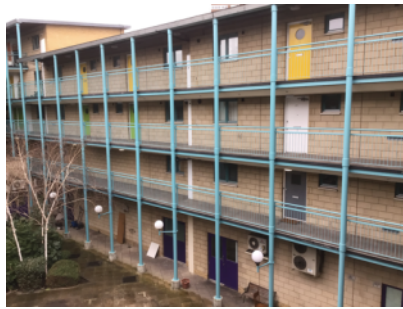
Windows and door glazing all above 1.1 m on common balconies.

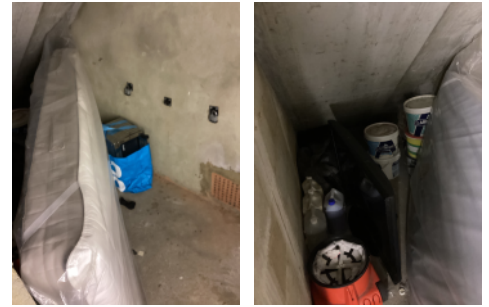
Task 9

The gas meter cupboard is being used for general storage which may cause damage to the gas installations. This cupboard should not be used for storage, or an appropriate barrier or enclosure provided to ensure the installations are protected from damage.

Source Version	1
Category	Fire Prevention
Sub Category	Gas
Action Required	The gas meter cupboard is being used for general storage which may cause damage to the gas installations. This cupboard should not be used for storage, or an appropriate barrier or enclosure provided to ensure the installations are protected from damage.
Priority	Medium
Status	Identified
Owner	Neighbourhood Services
Due Date	10 February 2021
