Fire Risk Assessment

Novello Court

Version 3

31 August 2023

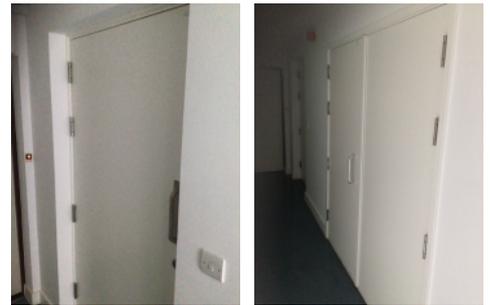
Task 3

Source Version	2
Category	Signs & Notices
Sub Category	Fire Door Signage
Action Required	Provide Fire Door Keep Locked Shut signs on the following doors: Both sets of doors to the pump room located on the ground floor outside of flat number 1
Priority	Low
Status	Identified
Owner	Neighbourhood Services
Due Date	16 February 2022
