Fire Risk Assessment

1-16 Belvedere Court

Version 7

16 August 2024

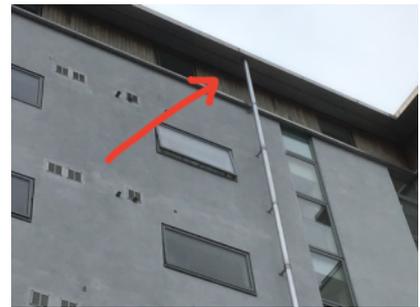
External walls – rear elevation

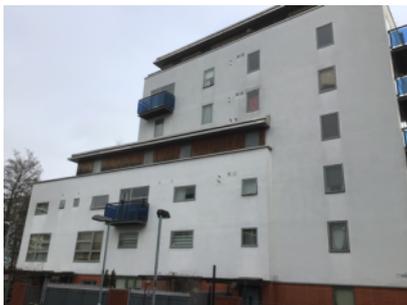
Timber cladding on the sixth floor.

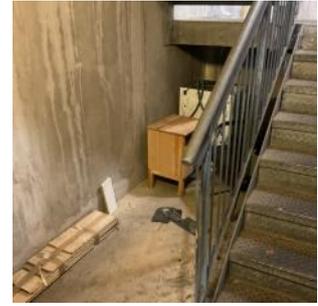
Clear common areas

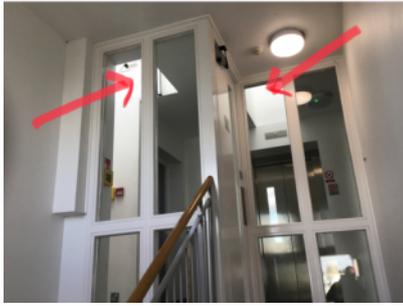
The positioning of the 6th floor lobby partition, means that the roof-light AOVs are only able to ventilate the top floor lobby, and will have no effect on the staircase where it is required. Ventilation is required for a building of this size and therefore this does not meet the minimum requirements of the building regulations at the time of construction which must have been signed off by the relative building control body. Recommendations regarding possible solutions to remedy this matter are provided within this report.

6th floor partition viewed from staircase showing position of AOVs

Alternatively, reconfigure the openable windows in the staircase to have window AOVs fitted.

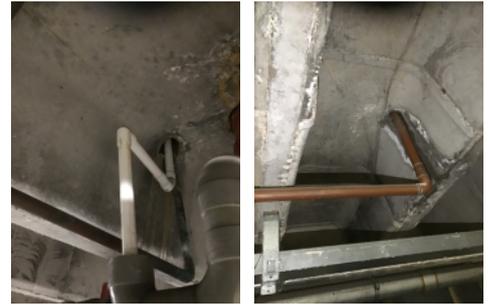
Cable and pipe penetrations in the underground carpark are for the most part, fire stopped to an acceptable standard. However, there are some smaller pipe penetrations which were noted not to have any fire stopping installed.

Source Version	1
Category	Escape Routes & Fire Spread
Sub Category	Construction and Glazing
Action Required	Provide fire stopping around pipe penetrations in the following locations:

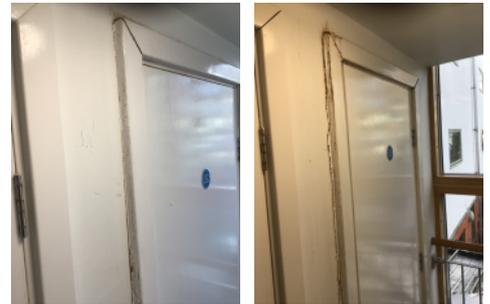
Task 15

There are water services riser doors (including frames) on the first and second floors which have been damaged, presumably by a severe water leak at some time. These should be repaired to an FD30S standard of fire resistance.

Source Version	1
Category	Escape Routes & Fire Spread
Sub Category	Fire Doors
Action Required	Repair the following doors and frames to ensure that afford at least FD30S standard of fire resistance : There are water services riser doors (including frames) on the first and second floors which have been damaged, presumably by a severe water leak at some time. Version 5. 14/9/22 This task is not yet complete.
Priority	Medium
Status	Identified
Owner	Customer Homes
Due Date	04 September 2020
