Fire Risk Assessment

17-42 Belvedere Court

Version 7

16 August 2024

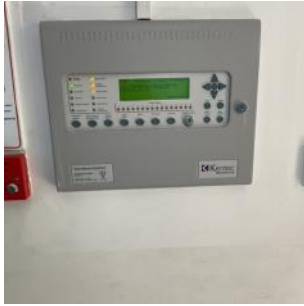
The new interim fire alarm is in the process of being commissioned.

Fault lights on fire alarm panel

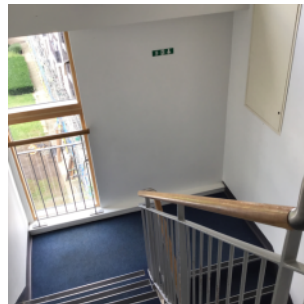
Escape route signage too small
