Fire Risk Assessment

43-68 Belvedere Court

Version 8

16 August 2024

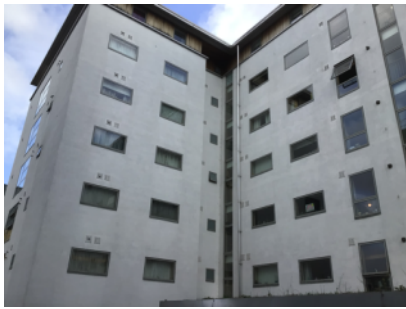
External walls - rear elevation

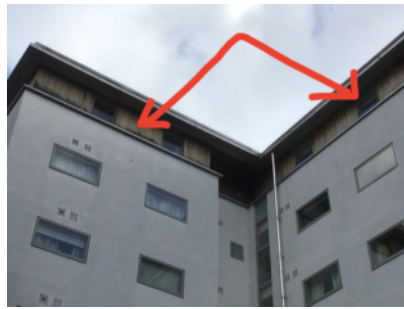
Showing timber cladding fitted on the sixth floor external walls.

Timber cladding, battens, foil insulation and sheathing board should be removed. The remaining timber studs and mineral wool insulation should be encapsulated with a minimum A2, s1-d0 rated sheathing board, aluminium support system and minimum A2, s1-d0 rated cladding. Siderise cavity barriers or similar barriers should be installed at compartment walls, floors and around openings including service penetrations.

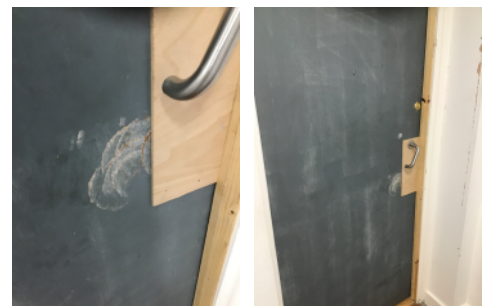
Task 5

Source Version	1
Category	Escape Routes & Fire Spread
Sub Category	Fire Doors
Action Required	Repair or replace the flat entrance door to flat 52 to an FD30S SC standard of fire resistance.
Priority	Medium
Status	Identified
Owner	Customer Homes
Due Date	04 September 2020

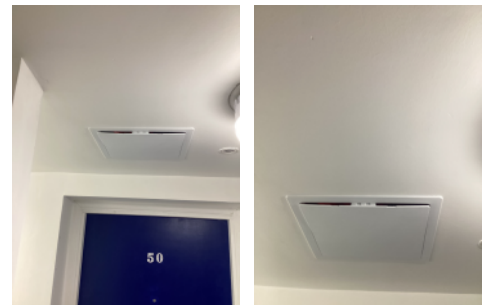
Task 11

Source Version	6
Category	Escape Routes & Fire Spread
Sub Category	Construction and Glazing
Action Required	<p>It is noted that new access panels in the common area ceilings do not appear to be of 30 minute fire resisting construction.</p>
Priority	Medium
Status	Identified
Owner	Customer Homes
Due Date	15 March 2023

There are access points and hatch’s cut into the ceiling presumably for the wiring of the new fire alarm system. These holes should be made up to the original fire resistance of the ceiling or be covered with a suitable fire resisting access hatch.
