Fire Risk Assessment

276 Forest Rd, Flats 11-21

Version 5

26 September 2024

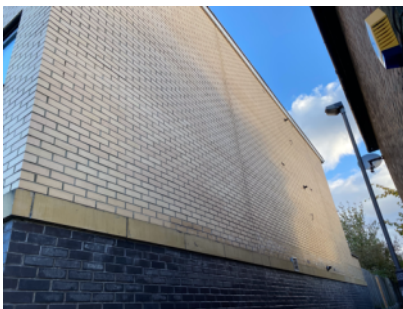
Brick/mortar faced external wall - side elevation

External walls are of brick/mortar construction, with sections of wall which are rendered.

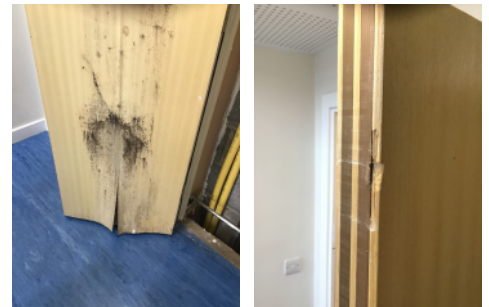
The fire-resisting door (left leaf) to the riser cupboard on the 2nd floor appears to have suffered water damage to its internal face to an extent which may have compromised its fire resistance. This door should be repaired or replaced to ensure it affords the required FD30S standard of fire resistance.

This should include the lip of the door which is damaged due to it catching on the opposing door bolt.

VERSION 2: The remedial work recommended in task from the previous FRA has not been completed

Action Required Repair the following doors to an FD30S standard:
