**Fire Risk Assessment**

**14 Graham Street**

Version 5

27 August 2024

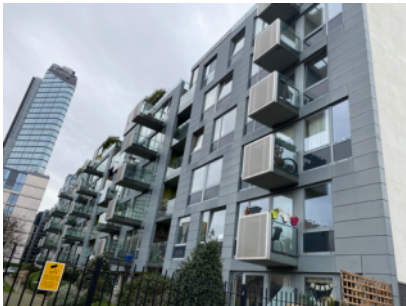
There is an identified (metallic) external wall system installed across the entire surface of the rear external wall, and around all faces of the fifth floor.

Unidentified (metallic) EWS - rear of building

The external walls at the rear elevation of the building have an unidentified (metallic) external wall system installed across the entire elevation

Attention is drawn to the Ministry of Housing, Communities & Local Government Consolidated Advice Note for building owners of multi-storey, multi-occupied residential buildings, dated January 2020. The Advice Note recommends that building owners should consider the risk of external fire spread as part of the fire risk assessment for multi-occupied residential buildings. Consideration has been given to this matter within this fire risk assessment. The Advice Note further recommends the assessment of the fire risks of any external wall system, irrespective of the height of the building.

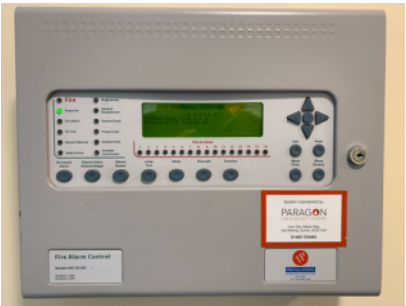
Fire alarm indicates fault, email sent to ISHA on 28/08/24 12:00 informing of the fault.

Panel for smoke detection for AOV actuation

The fire alarm system was noted as being in fault mode and should be serviced by an engineer.
