Fire Risk Assessment

321 Green Lanes

Version 5

12 August 2024

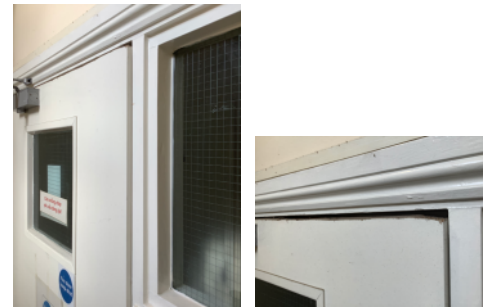
Task 8

Source Version	2
Category	Escape Routes & Fire Spread
Sub Category	Fire Doors
Action Required	Re-hang the first floor lobby door to enable the doors to easily close, and also to reduce the gap at the top of the door.
	Version 3. 26/9/22 This task is not complete.
	Version 4. 12/08/2024 This task remains outstanding.
Priority	High
Status	Identified
Owner	Customer Homes
Due Date	26 December 2021
