Fire Risk Assessment

3-32, 857 Lea Bridge Road

Version 5

26 September 2024

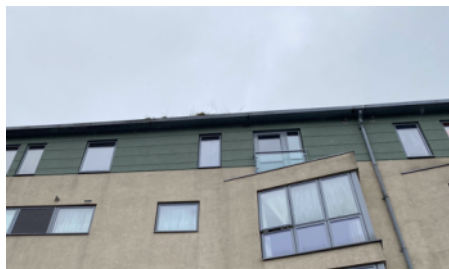
Unidentified external wall system
installed on the fourth floor.

Assessment of the fire risks of external walls and any cladding are excluded from the scope of this current fire risk assessment, as this is outside our expertise. (6) Accordingly, it is strongly recommended that you obtain advice from qualified and competent specialists on the nature of, and fire risks associated with, the external wall construction, including any cladding, of this building.

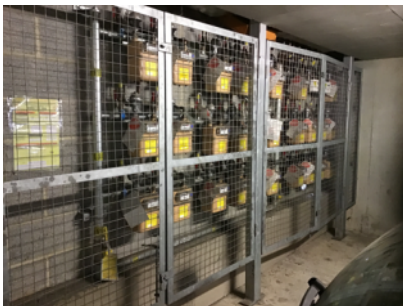
Gas meters are located within a secured cage in the undercroft carpark.

Gas meters located within the undercroft carpark

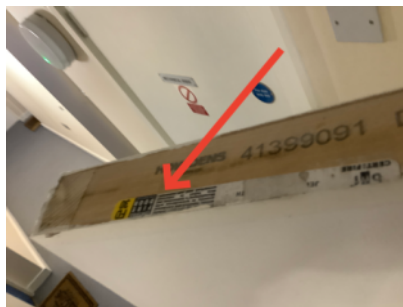
FD30 certification on staircase doors

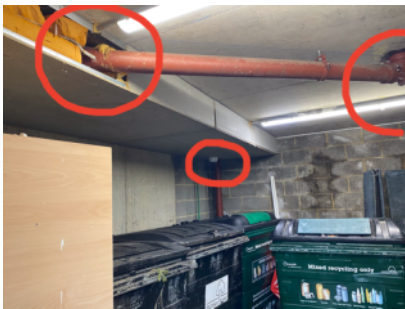
Large pipe penetrations without fire stopping within the bin store.

5	Escape Routes & Fire Spread	Construction and Glazing	<p>Provide fire stopping around pipe penetrations in the following locations:</p> <p>Within the bin store, which is located externally. Although the bin store is located externally it appears these penetrations through the concrete slab and into the flats above.</p> <p>VERSION 3: The remedial work, recommended in previous FRAs has not been completed, and therefore remains “identified” within this version of the FRA.</p> <p>13/09/2023 This task is still outstanding.</p> <p>Version 5. 26/09/24 Although some fire stopping has been carried out there are 2 areas which still require this.</p>	High	Identified
---	--------------------------------	-----------------------------	---	------	------------

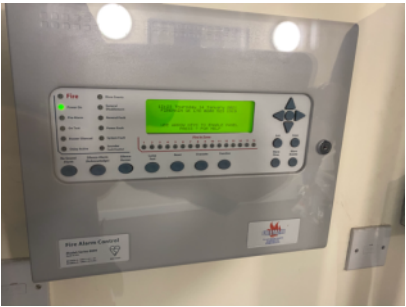
The fire alarm panel.

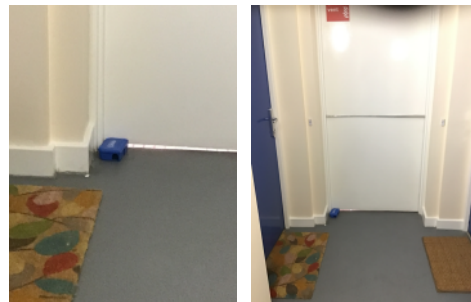
Task 1

Source Version	1
Category	Escape Routes & Fire Spread
Sub Category	Fire Doors
Action Required	<p>Repair the following doors to an FD30S standard:</p> <p>The smoke shaft doors adjacent to flats 20, 28 and 32 have an excessive gap at the threshold. These should be repaired or replaced.</p> <p>VERSION 3: The remedial work, recommended in previous FRAs has not been completed, and therefore remains “identified” within this version of the FRA.</p> <p>13/09/2023 This task is still outstanding.</p> <p>Version 5. 26/09/24 This task remains outstanding.</p>
Priority	High
Status	Identified
Owner	Customer Homes
Due Date	16 May 2020

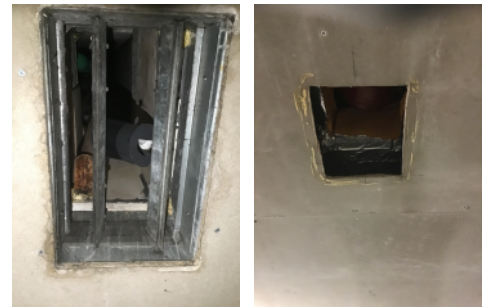
Task 3

Source Version	1
Category	Escape Routes & Fire Spread
Sub Category	Construction and Glazing
Action Required	<p>Within the undercroft carpark, there are breaches of the fire resisting ceiling which have no fire stopping, or, are covered with grilles and inspection plates which are not fire resisting. It is imperative that the integrity of the concrete slab between the carpark and the flats above is maintained to ensure that any vehicle fire is not able to affect the flats above.</p> <p>VERSION 3: The remedial work, recommended in previous FRAs has not been completed, and therefore remains “identified” within this version of the FRA.</p> <p>13/09/2023 This task is still outstanding.</p> <p>Version 5. 26/09/24 This task remains outstanding.</p>
Priority	High
Status	Identified
Owner	Customer Homes
Due Date	16 May 2020
