Fire Risk Assessment

1-26 Mildmay Avenue

Version 7

30 August 2024

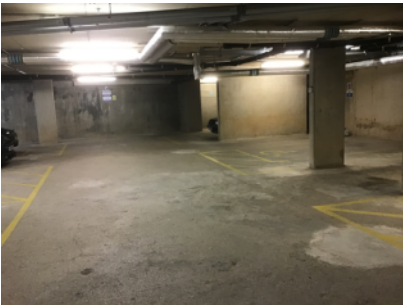
Basement carpark

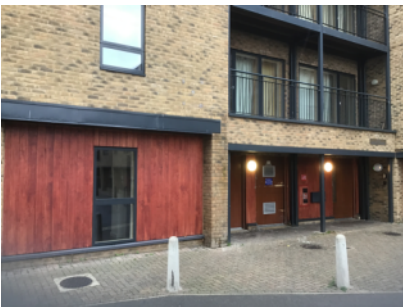
Ground floor partially timber clad

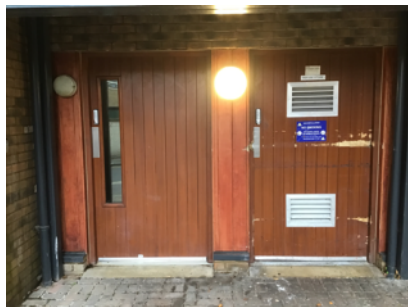
Access to basement carpark (left), and refuse store (right)

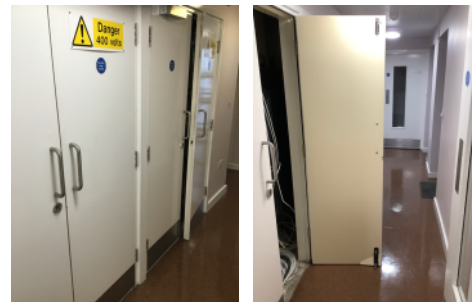
Task 1

The ground floor, 2nd floor and 4th floor cupboards can still be opened even when locked. The first floor cupboard has left unlocked and cannot be relocked with any kind of FB key.

Source Version	1
Category	Escape Routes & Fire Spread
Sub Category	Fire Doors
Action Required	<p>Replace the locks, in the following doors:</p> <p>Electrical riser cupboard door (both doors) ground floor</p> <p>Electrical riser cupboard door (both doors), 1st floor.</p> <p>Electrical riser cupboard door (both doors), 2nd floor.</p> <p>Electrical riser cupboard door (right hand), 4th floor.</p> <p>NB: these doors are provided with self closing devices and therefore this task has been afforded a lower priority.</p> <p>Version 4 - 17/11/21 This task is still outstanding.</p> <p>31/08/23 This task is still outstanding.</p> <p>Version 7, 30/08/2024 The ground floor, 2nd floor and 4th floor cupboards can still be opened even when locked. First floor are left unlocked and cannot be relocked with any kind of FB key. This task remains outstanding.</p>
Priority	Low
Status	Identified
Owner	Neighbourhood Services

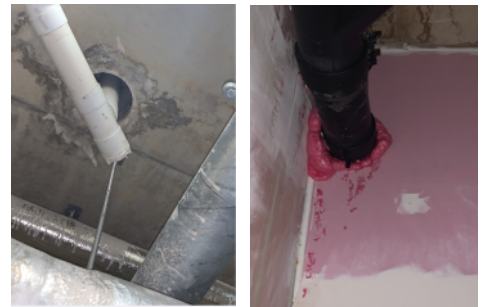
Task 2

There are numerous penetrations through the concrete slab ceiling in the basement carpark and associated plant rooms/intake rooms which require fire stopping. Some penetrations have been sealed, however incorrect fire stopping techniques and materials have been used.

Source Version	2
Category	Escape Routes & Fire Spread
Sub Category	Construction and Glazing
Action Required	<p>There are numerous penetrations through the concrete slab ceiling in the basement carpark and associated plant rooms/intake rooms which require fire stopping.</p> <p>Some penetrations have been sealed, however incorrect fire stopping techniques and materials have been used.</p> <p>It is recommended to conduct a full fire stopping survey in this area to ensure there is adequate fire separation between the basement carpark and the flats above.</p> <p>31/08/23 This task is still outstanding.</p> <p>Version 7, 30/08/2024 This task remains outstanding.</p>
Priority	High
Status	Identified
Owner	Customer Homes
Due Date	16 March 2021

It is recommended to conduct a full fire stopping survey in this area to ensure there is adequate fire separation between the basement carpark and the flats above.
