**Fire Risk Assessment**

**220-222 A-H Queensbridge Road**

Version 4

15 August 2024

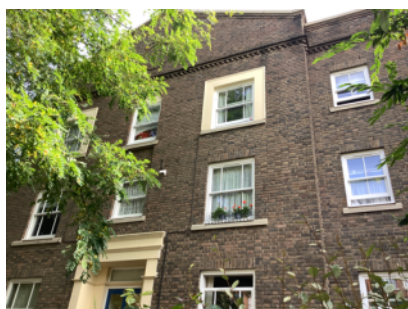
External walls - front elevation

Brick external walls with no external wall systems installed.

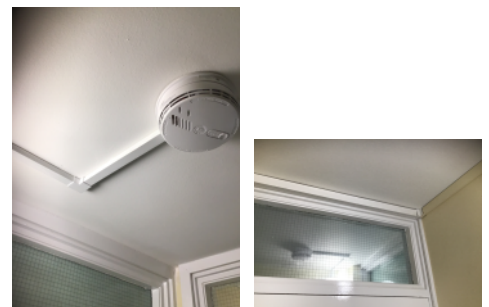
Source Version	1
Category	Escape Routes & Fire Spread
Sub Category	Ease of Use
Action Required	<p>Some wiring within common parts are suspended in uPVC conduit. A requirement introduced in 2015 in BS 7671 which covers electrical installations in the UK, states that all new wiring systems to use metal, rather than plastic, to support cables in escape routes, to prevent their premature collapse in the event of a fire.</p> <p>Version 4. 15/08/2024 This task remains outstanding.</p>
Priority	Advisory
Status	Identified
Owner	Customer Homes
Due Date	28 July 2022

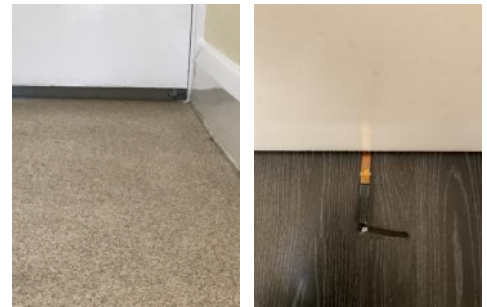
Source Version	1
Category	Escape Routes & Fire Spread
Sub Category	Fire Doors
Action Required	<p>Re-hang the following doors to reduce the gaps around the doors:</p> <p>The threshold gap on all Lobby doors. The doors on the 1st and 2nd floors have a threshold below the door which mitigates the risk of the passage of smoke to some extent and therefore is of a lower priority. However, the ground floor lobby door does not and this is of a higher priority.</p> <p>VERSION 2: This task, recommended in the previous FRA, has not been completed and therefore remains as an identified task within this version of the buildings fire risk assessment.</p> <p>Version 4. 15/08/2024 This task remains outstanding</p>
Priority	Medium
Status	Identified
Owner	Customer Homes
Due Date	26 January 2021
