Fire Risk Assessment

26-30 Southgate Road

Version 8

14 August 2024

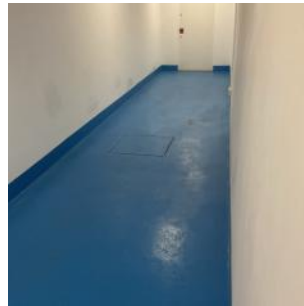
Combustible free electrical cupboard

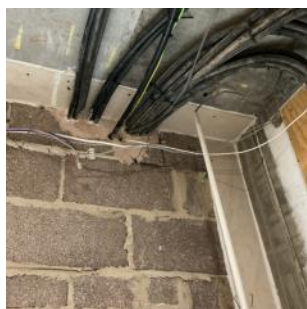
Fire stopping in the communications cupboards

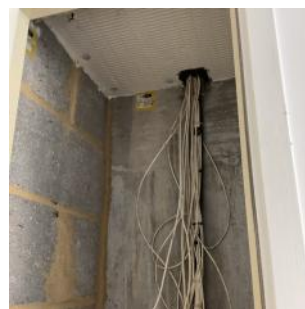
Reasonable fire stopping in electrical room.

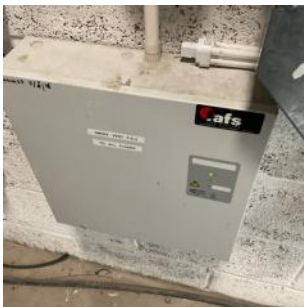
Smoke vent control
