Fire Risk Assessment

1-8 Stables Lodge

Version 5

21 August 2024

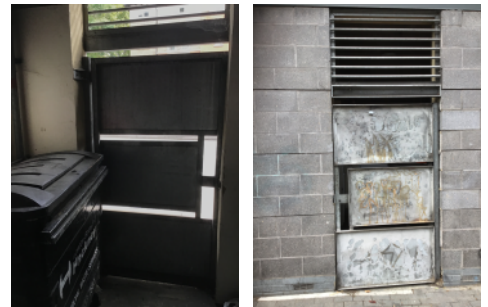
Task 4

Source Version	2
Category	Fire Prevention
Sub Category	Arson
Action Required	<p>It is recommended to install a grill or covering over the large openings in the bin store door from the street. The current arrangement effectively provides sufficient opening for a fire setter to reach the bins located within. The bin store also houses the gas meter cupboard.</p> <p>22/08/23 This task is still outstanding.</p> <p>21/08/2024 This task remains outstanding.</p>
Priority	Low
Status	Identified
Owner	Customer Homes
Due Date	30 September 2021

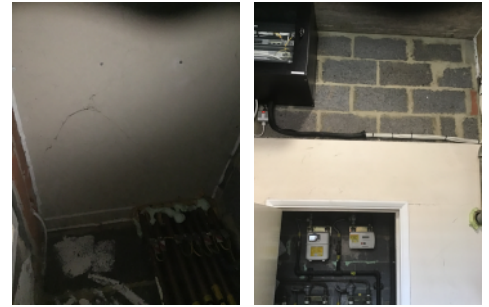
Task 11

Source Version	1
Category	Fire Prevention
Sub Category	Gas
Action Required	The gas meter cupboard does not have any ventilation which may contradict guidance for locating such gas installations. Advice should be sought from the appropriate gas supply agency to ensure it complies with regulations.
	22/08/23 This task is still outstanding.
	Version 5. 21/08/2024 This task remains outstanding.
Priority	Advisory
Status	Identified
Owner	Customer Homes
Due Date	09 October 2022

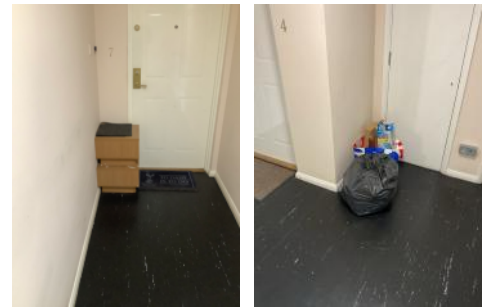
Task 14

Source Version	1
Category	Escape Routes & Fire Spread
Sub Category	Ease of Use
Action Required	<p>VERSION 2: The following task, generated in the previous FRA, has not been completed and therefore remains “identified” in this version of the FRA:</p> <p>VERSION 3: The following task, generated in the previous FRA, has not been completed and therefore remains “identified” in this version of the FRA:</p> <p>Obstructions should be removed from the escape routes in the following locations:</p> <p>On all landings there were found to be obstructions on the escape routes which should be removed.</p> <p>22/08/23 This task is still outstanding.</p> <p>21/08/2024 This task remains outstanding.</p>
Priority	Medium
Status	Identified
Owner	Neighbourhood Services
Due Date	09 October 2020

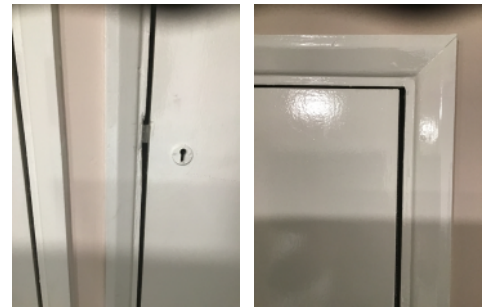
Task 15

There are excessive gaps on all riser cupboard doors, in some cases as much as 13mm. This exceeds the maximum gap permitted for fire doors (3mm +/- 1mm). These doors should be adjusted to reduce these gaps.

Re-hang the following doors to reduce the gaps around the doors:

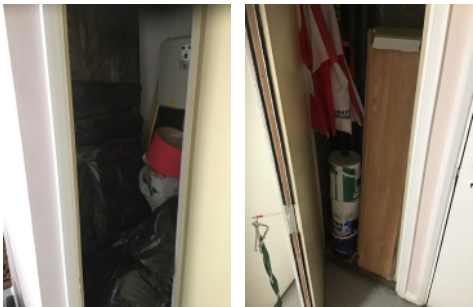
Task 16

Source Version	1
Category	Fire Prevention
Sub Category	Housekeeping
Action Required	<p>VERSION 2: The following task, generated in the previous FRA, has not been completed and therefore remains “identified” in this version of the FRA:</p> <p>VERSION 3: The following task, generated in the previous FRA, has not been completed and therefore remains “identified” in this version of the FRA:</p> <p>The storage of combustible items in riser cupboards should be prohibited.</p> <p>22/08/23 This task is still outstanding.</p> <p>Version 5. 21/08/2024 This task remains outstanding.</p>
Priority	High
Status	Identified
Owner	Neighbourhood Services
Due Date	08 January 2020

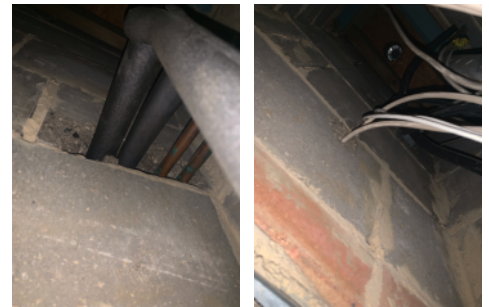
Task 17

There are numerous pipe and cable penetrations within riser cupboards on all floors which are not fire stopped. These require fire stopping to ensure adequate compartmentation is provided between risers and the common parts.

Provide fire stopping around pipe and cable penetrations in the following locations:
