Fire Risk Assessment 10 Stock Orchard Crescent Version 4

26 September 2024

Address line 1	10 Stock Orchard Crescent
Town	Islington
Postcode	N7 9SL
FRA Type	Type 1 - Common parts only (non-

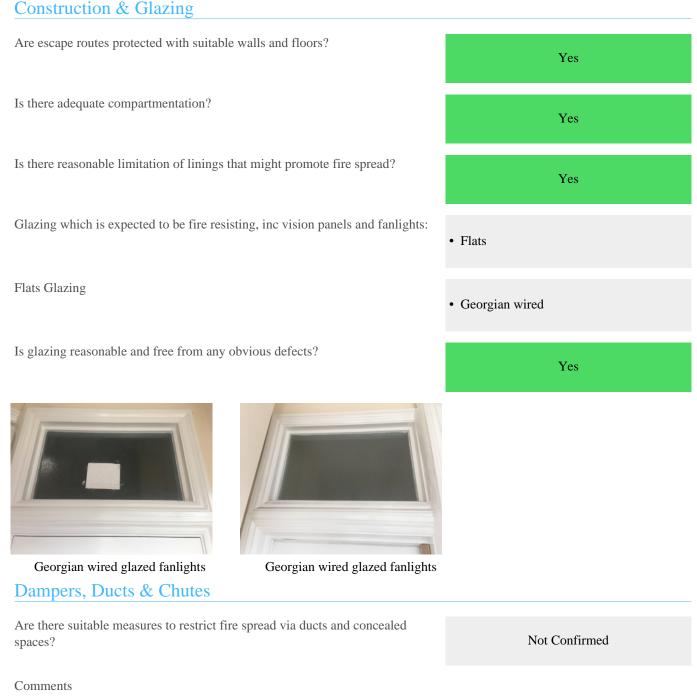
Flat entrance door

The flat entrance doors within the building could not be assessed due to access within the scope of this Type 1 Fire Risk Assessment. However from external examination only, the flat entrance doors appear to be flush timber original doors, in good condition and appear to be recently installed. It is reasonable to assume these doors would provide a notional 30 minutes fire resistance. Both the flat entrance doors appear to be of the same age, condition and design and were probably all installed at the same time. It is therefore reasonable to assume that they are of the same FD30 (notional) fire resisting standard. The provision and condition of self closing devices, intumescent strips/cold smoke seals, and effective door closing action of these doors however could not be assessed and this should be confirmed ensure all doors afford FD30SC standard of fire resistance.

The flat entrance door on the right hand side opens out onto the common area. This may be the only option due to the layout of the staircase inside of the flat entrance. However, this does raise the risk of the door not being able to be fully opened if there is any obstructions in the common area immediately outside of the flat (as was the case at the time of the inspection). It is therefore imperative that the common area is clear of combustibles at all times, and it is recommended to review the layout of this flat entrance.
