**Fire Risk Assessment**

**1-10 Trays Hill Close**

Version 5

20 September 2024

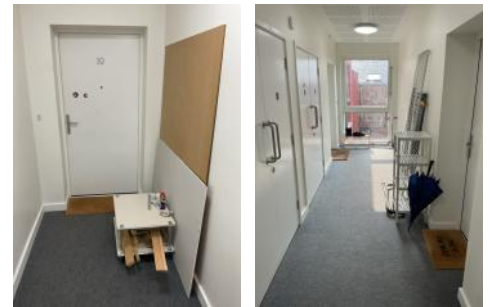
Source Version	2
Category	Fire Prevention
Sub Category	Housekeeping
Action Required	Although the amount of combustibles currently in escape routes is not unreasonable, routes should be monitored to ensure the amount of items does not build-up.  Version 5. 20/09/24 This task remains outstanding.
Priority	Low
Status	Identified
Owner	Neighbourhood Services
Due Date	04 June 2021

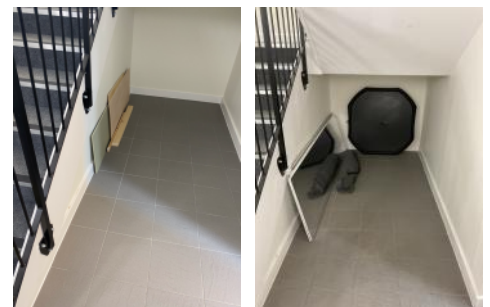
Source Version	2
Category	Fire Prevention
Sub Category	Housekeeping
Action Required	Although the amount of combustibles currently in communal areas is not unreasonable, the premises should be monitored to ensure the amount of items does not build-up.  Version 5. 20/09/24 This task remains outstanding.
Priority	Medium
Status	Identified
Owner	Neighbourhood Services
Due Date	03 December 2020
