Fire Risk Assessment

1-26, 50 Well Street

Version 6

12 September 2024

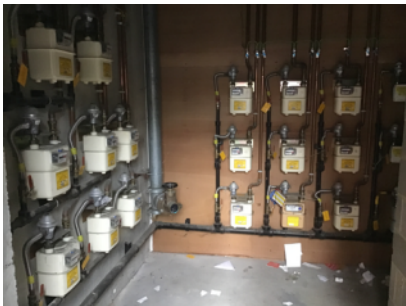
Gas meters located in externally accessed ventilated room.

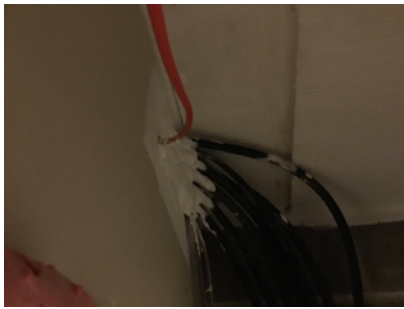
Some fire stopping has been installed in riser cupboards, however, this has been installed in some penetrations and not others. Also, where fire stopping has been installed, often it was found to be of an unacceptable standard.

Example of fire stopping within riser cupboards

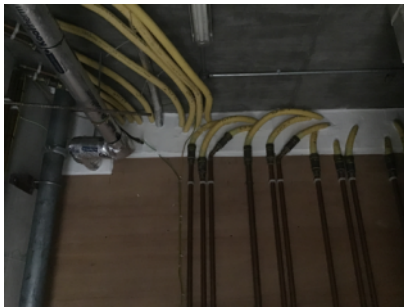
Fire stopping within gas meter cupboard

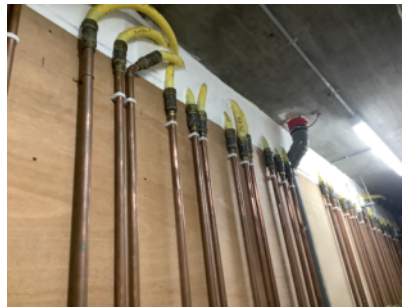
It appears fire stopping has been installed through the vertical levels of the gas riser. This may compromise the required ventilation for this riser. It is advised advice is sought from the appropriate gas supply body to ensure that this complies and does not contradict with ventilation requirements.

Fire stopping within gas meter room

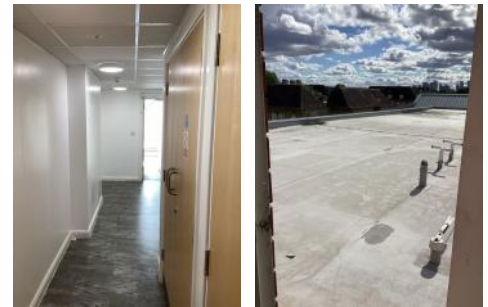
Task 11

Source Version	6
Category	Escape Routes & Fire Spread
Sub Category	Fire Doors
Action Required	Repair the following doors to an FD30S standard: First floor lift lobby vent door
Priority	High
Status	Identified
Owner	Customer Homes
Due Date	11 December 2024
